**DEPARTMENT OF TRANSPORTATION**

Contract #: 04-0120F4Cty: SF/ALA Rte: 80 PM: 13.2/13.9File #: 1.28**WELDING INSPECTION REPORT****Resident Engineer:** Casey, William**Address:** 333 Burma Road**City:** Oakland, CA 94607**Report No:** WIR-026722**Date Inspected:** 15-Nov-2011**Project Name:** SAS Superstructure**OSM Arrival Time:** 700**Prime Contractor:** American Bridge/Fluor Enterprises, a JV**OSM Departure Time:** 1730**Contractor:** American Bridge/Fluor Enterprises, a JV**Location:** Job Site**CWI Name:** Bernie Docena**CWI Present:** Yes No**Inspected CWI report:** Yes No N/A**Rod Oven in Use:** Yes No N/A**Electrode to specification:** Yes No N/A**Weld Procedures Followed:** Yes No N/A**Qualified Welders:** Yes No N/A**Verified Joint Fit-up:** Yes No N/A**Approved Drawings:** Yes No N/A**Approved WPS:** Yes No N/A**Delayed / Cancelled:** Yes No N/A**Bridge No:** 34-0006**Component:** SAS OBG**Summary of Items Observed:**

## WELDING INSPECTION REPORT

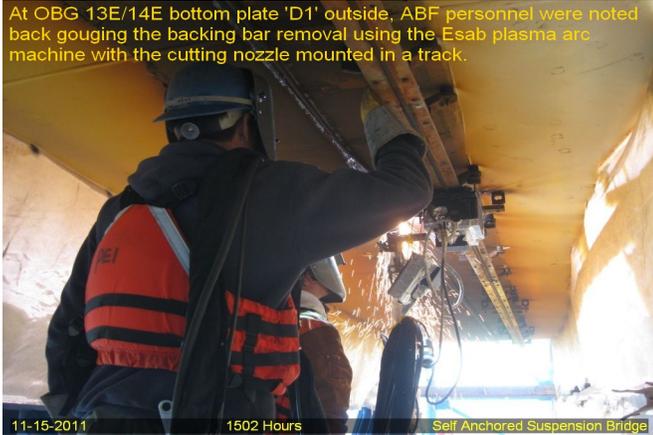
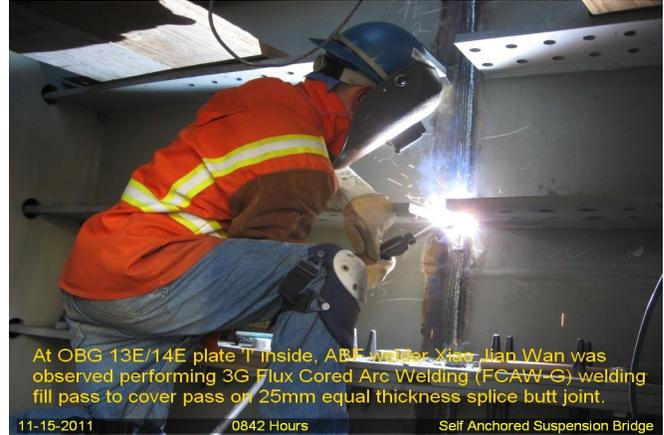
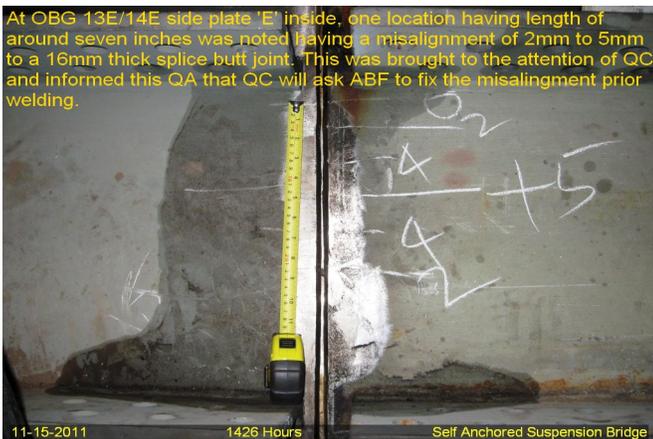
At OBG 13E/14E vertical plate 'I' inside, QA randomly observed ABF/JV qualified welder Xiao Jian Wan continuing to perform fill pass to cover pass welding on Complete Joint Penetration (CJP) splice butt joint. The welder was observed manually welding in the 3G (vertical) position utilizing a Flux Cored Arc Welding (FCAW-G) with E71T-1M, 1/16" diameter wire electrode and implementing Caltrans approved Welding Procedure Specification (WPS) ABF-WPS-D15-3040B-3. The 25mm equal thickness Seismic Performance Critical Member (SPCM) joint being welded has a single V-groove butt joint with backing bar that will be removed and back gouged then back welded. During welding, ABF Quality Control (QC) Bernie Docena was noted monitoring the welding parameters of the welder. Measured parameters during welding were 255 amperes, 23.5 volts and travel speed of 180mm per minute with calculated heat input of 2.0 Kjoules/mm which deemed in compliance to the contract requirements. During the shift, cover pass FCAW-G welding was completed and the welder has held the preheat of more than 200°F for three more hours after welding as required. The welder has started flush grinding the weld cover.

1. OBG 12E/13E side plate C1.2/C2 outside - QA VT/MT verified

At OBG 13E/14E bottom plate 'D1' outside, QA randomly observed ABF personnel James Zhen and Wai Kitlai perform plasma arc gouging on the backing bar removal of the splice butt joint. The personnel were using an Esab plasma arc gouging machine that has the nozzle holder attached to a Bug-o track. Gouging of the backing bar was not completed today and should continue tomorrow.

At OBG 13E/14E side plate 'C' inside, this QA performed a preliminary fit up inspection/verification on the butt joint fit up alignment. The OBG side plates were measured 16mm wall thickness. The following measurements in between the stiffeners were noted during the verification;

The rejectable misalignments noted above were brought to the attention of ABF QC Bonifacio Daquinag but according to QC, they will ask ABF to fix the misalignments before welding.
