**DEPARTMENT OF TRANSPORTATION**

Contract #: 04-0120F4Cty: SF/ALA Rte: 80 PM: 13.2/13.9File #: 1x.28**WELDING INSPECTION REPORT****Resident Engineer:** Casey, William**Address:** 333 Burma Road**City:** Oakland, CA 94607**Report No:** WIR-026742**Date Inspected:** 21-Nov-2011**Project Name:** SAS Superstructure**OSM Arrival Time:** 630**Prime Contractor:** American Bridge/Fluor Enterprises, a JV**OSM Departure Time:** 1530**Contractor:** American Bridge/Fluor Enterprises, a JV**Location:** Jobsite**CWI Name:** Bernie Docena**CWI Present:** Yes No**Inspected CWI report:** Yes No N/A**Rod Oven in Use:** Yes No N/A**Electrode to specification:** Yes No N/A**Weld Procedures Followed:** Yes No N/A**Qualified Welders:** Yes No N/A**Verified Joint Fit-up:** Yes No N/A**Approved Drawings:** Yes No N/A**Approved WPS:** Yes No N/A**Delayed / Cancelled:** Yes No N/A**Bridge No:** 34-0006**Component:** Bike Path - Skyway**Summary of Items Observed:**

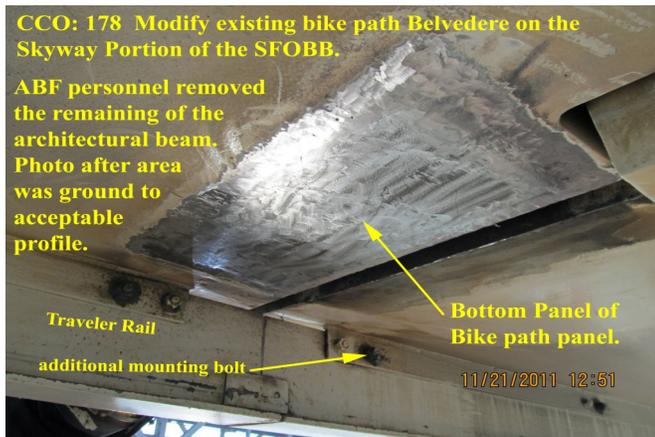
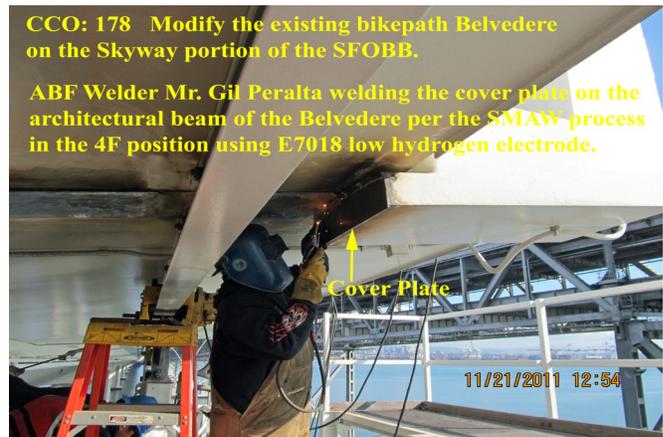
This QA Inspector randomly observed ABF welder Mr. Gil Peralta performing the Air-Carbon-Arc gouge operation to remove the remnant material - (at least 10 mm of material) from the section of the architectural beam that was previously removed from the bottom panel of the Bike Path at Pier Location 8E. This QA Inspector observed that the removal of remnant material did not damage the remainder of the Bike Path bottom panel. The steel surface was ground flush and there were no areas that were damaged that required any weld repairs to be performed. See attached Photos.

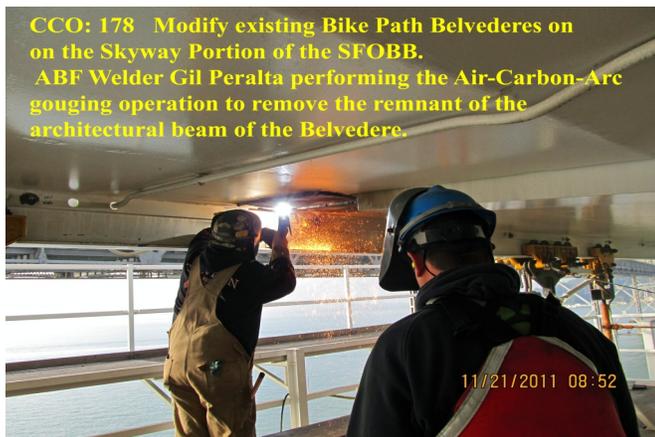
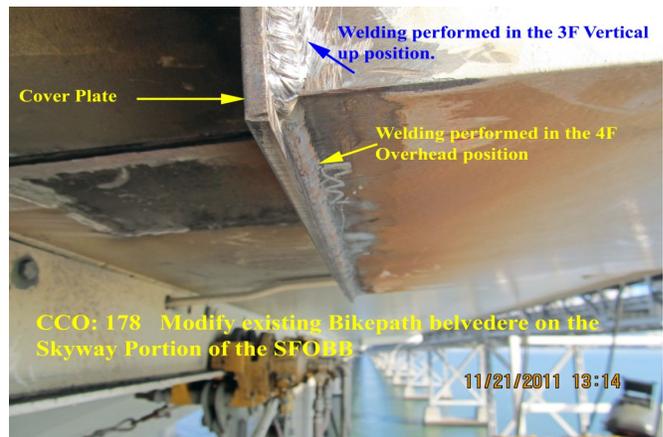
This QA Inspector randomly observed ABF welder Mr. Gil Peralta (Welder ID 9543) performing the fillet weld operation on the new cover plate to the remaining architectural beam of the belvedere at Pier Location 8E per the Shielded Metal Arc Welding (SMAW) process in the (3F) vertical and (4F) overhead positions. This QA Inspector observed QC Inspector Mr. Bernie Docena verify prior to the start of the fillet weld operation that the welding parameters (Amps, Volts and Travel Speed) and the preheat temperature of 70 degrees F were established and in accordance with WPS-F1200A. See attached Photos.

the fillet weld to verify the fillet weld size and weld quality. The fillet weld size and quality visually appeared to be in general compliance with AWS D1.5-2002 Section 3.6 and CCO 178.
