DEPARTMENT OF TRANSPORTATION

Contract #: 04-0120F4Cty: SF/ALA Rte: 80 PM: 13.2/13.9File #: 1x.28**WELDING INSPECTION REPORT****Resident Engineer:** Casey, William**Address:** 333 Burma Road**City:** Oakland, CA 94607**Report No:** WIR-026743**Date Inspected:** 22-Nov-2011**Project Name:** SAS Superstructure**OSM Arrival Time:** 630**Prime Contractor:** American Bridge/Fluor Enterprises, a JV**OSM Departure Time:** 1530**Contractor:** American Bridge/Fluor Enterprises, a JV**Location:** Jobsite**CWI Name:** Mike Johnson**CWI Present:** Yes No**Inspected CWI report:** Yes No N/A**Rod Oven in Use:** Yes No N/A**Electrode to specification:** Yes No N/A**Weld Procedures Followed:** Yes No N/A**Qualified Welders:** Yes No N/A**Verified Joint Fit-up:** Yes No N/A**Approved Drawings:** Yes No N/A**Approved WPS:** Yes No N/A**Delayed / Cancelled:** Yes No N/A**Bridge No:** 34-0006**Component:** Bike Path - Skyway**Summary of Items Observed:**

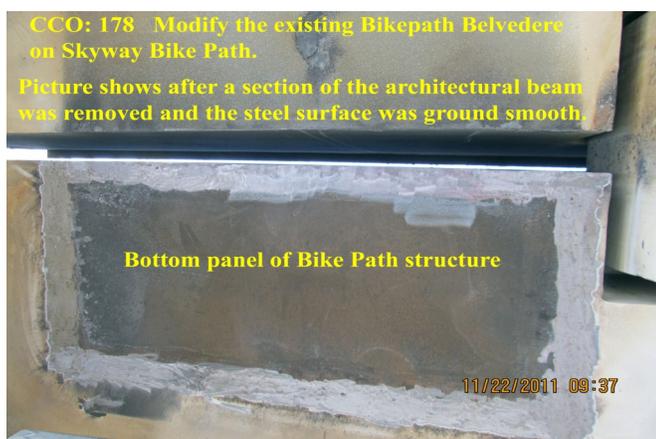
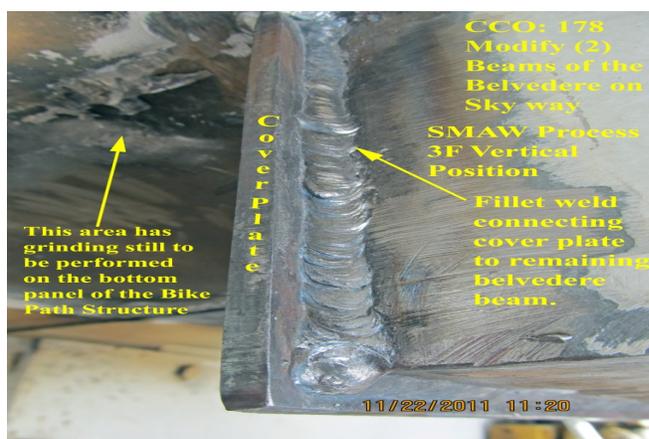
This QA Inspector randomly observed ABF welder Mr. Gil Peralta performing the Air-Carbon-Arc gouge operation to remove the remnant material - (at least 10 mm of material) from the section of the architectural beam that was previously removed from the bottom panel of the Bike Path at Pier Location 8E - (2nd location). This QA Inspector observed that the removal of remnant material did not damage the remainder of the Bike Path bottom panel. The steel surface was ground flush and there were no areas that were damaged that required any weld repairs to be performed. See attached Photos.

This QA Inspector randomly observed ABF welder Mr. Gil Peralta (Welder ID 9543) performing the fillet weld operation on the new cover plate to the remaining architectural beam of the belvedere at Pier Location 8E - (2nd location) per the Shielded Metal Arc Welding (SMAW) process in the (3F) vertical and (4F) overhead positions. This QA Inspector observed QC Inspector Mr. Mike Johnson verify prior to the start of the fillet weld operation that the welding parameters (Amps, Volts and Travel Speed) and the preheat temperature of 70 degrees F were established and in accordance with WPS-F1200A. See attached Photos.
