DEPARTMENT OF TRANSPORTATION

Contract #: 04-0120F4Cty: SF/ALA Rte: 80 PM: 13.2/13.9File #: 1.28**WELDING INSPECTION REPORT****Resident Engineer:** Casey, William**Address:** 333 Burma Road**City:** Oakland, CA 94607**Report No:** WIR-026751**Date Inspected:** 22-Nov-2011**Project Name:** SAS Superstructure**OSM Arrival Time:** 700**Prime Contractor:** American Bridge/Fluor Enterprises, a JV**OSM Departure Time:** 1730**Contractor:** American Bridge/Fluor Enterprises, a JV**Location:** Job Site**CWI Name:** Steve Jensen**CWI Present:** Yes No**Inspected CWI report:** Yes No N/A**Rod Oven in Use:** Yes No N/A**Electrode to specification:** Yes No N/A**Weld Procedures Followed:** Yes No N/A**Qualified Welders:** Yes No N/A**Verified Joint Fit-up:** Yes No N/A**Approved Drawings:** Yes No N/A**Approved WPS:** Yes No N/A**Delayed / Cancelled:** Yes No N/A**Bridge No:** 34-0006**Component:** OBG Sections**Summary of Items Observed:**

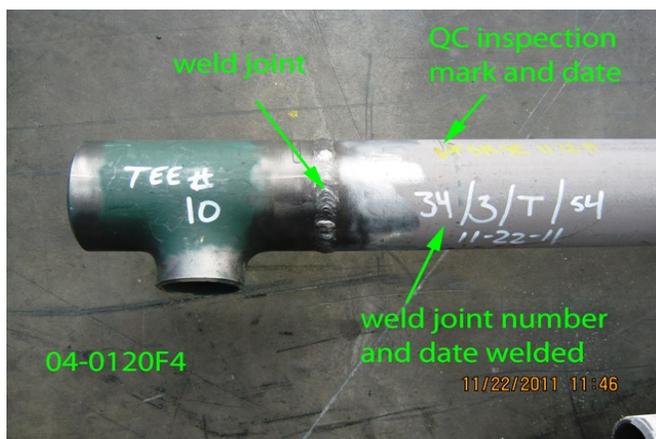
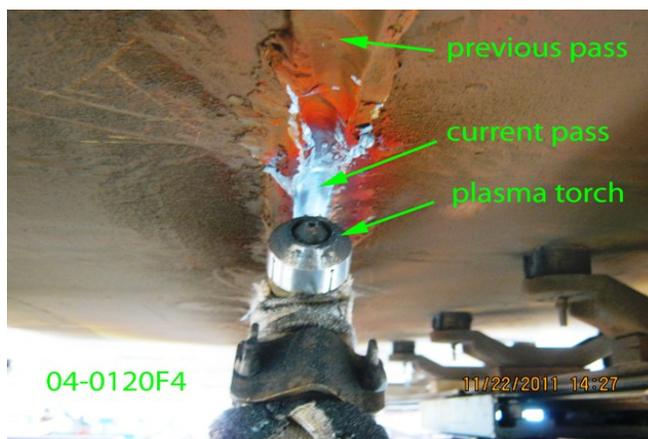
13W/14W – weld joint D – This QA Inspector observed ABF welding personnel Jeremy Dolman (#5042) using a plasma torch to remove the backing bar and back gouge the 30 mm thick section of the weld joint (D-3) from the bottom of the OBG section. See photo below. Work at this location was not completed this date.
