Contract #: 04-0120F4Cty: SF/ALA Rte: 80 PM: 13.2/13.9File #: 82.28**WELDING INSPECTION REPORT****Resident Engineer:** Casey, William**Address:** 333 Burma Road**City:** Oakland, CA 94607**Report No:** WIR-026791**Date Inspected:** 30-Nov-2011**Project Name:** SAS Superstructure**OSM Arrival Time:** 600**Prime Contractor:** American Bridge/Fluor Enterprises, a JV**OSM Departure Time:** 1430**Contractor:** Westmont Industries**Location:** Santa Fe Springs, CA**CWI Name:** Chris Concha**CWI Present:** Yes No**Inspected CWI report:** Yes No N/A**Rod Oven in Use:** Yes No N/A**Electrode to specification:** Yes No N/A**Weld Procedures Followed:** Yes No N/A**Qualified Welders:** Yes No N/A**Verified Joint Fit-up:** Yes No N/A**Approved Drawings:** Yes No N/A**Approved WPS:** Yes No N/A**Delayed / Cancelled:** Yes No N/A**Bridge No:** 34-0006**Component:** Maintenance Travelers**Summary of Items Observed:**

WELDING INSPECTION REPORT

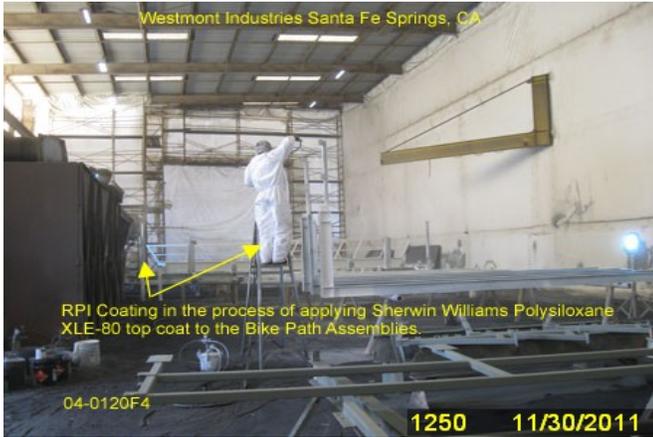
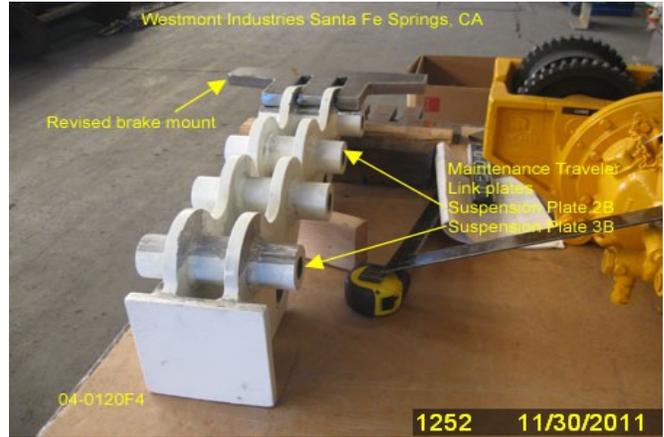
the morning this QA Inspector randomly observed that RPI personnel performing top coating application and using the Sherwin Williams Polysiloxane XLE-80 on the above mentioned material.

QA Inspector sampled of part A, and part B, of Sherwin Williams Polysiloxane XLE-80 Coating representing 90 gallons. QA Inspector assigned Caltrans Lot #B208-030-11 and TL-101 # 712428.
