DEPARTMENT OF TRANSPORTATION

Quality Assurance and Source Inspection

Contract #: 04-0120F4Cty: SF/ALA Rte: 80 PM: 13.2/13.9File #: 1.28**WELDING INSPECTION REPORT****Resident Engineer:** Casey, William**Address:** 333 Burma Road**City:** Oakland, CA 94607**Report No:** WIR-026803**Date Inspected:** 02-Dec-2011**Project Name:** SAS Superstructure**OSM Arrival Time:** 700**Prime Contractor:** American Bridge/Fluor Enterprises, a JV**OSM Departure Time:** 1530**Contractor:** American Bridge/Fluor Enterprises, a JV**Location:** Job Site**CWI Name:** Fred Von Hoff**CWI Present:** Yes No**Inspected CWI report:** Yes No N/A**Rod Oven in Use:** Yes No N/A**Electrode to specification:** Yes No N/A**Weld Procedures Followed:** Yes No N/A**Qualified Welders:** Yes No N/A**Verified Joint Fit-up:** Yes No N/A**Approved Drawings:** Yes No N/A**Approved WPS:** Yes No N/A**Delayed / Cancelled:** Yes No N/A**Bridge No:** 34-0006**Component:** SAS OBG**Summary of Items Observed:**

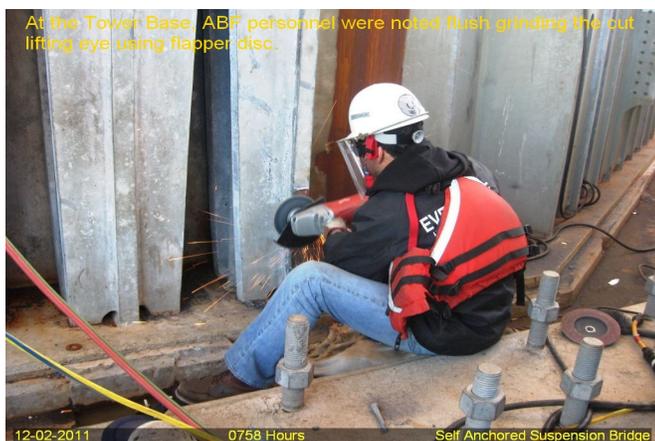
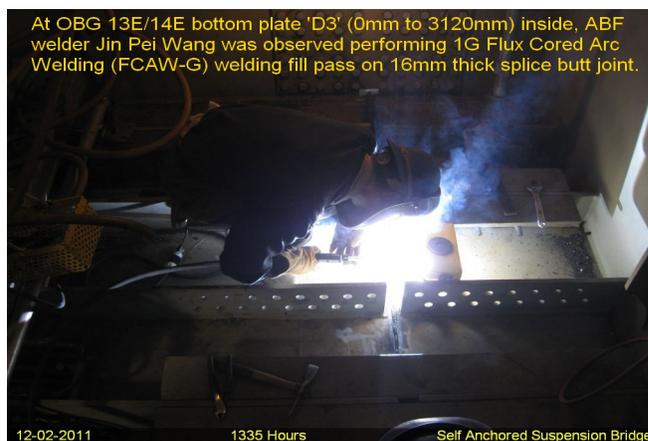
At the Tower Base, this QA together with fellow QA Doug Frey performed Tower survey and observation on the ongoing cutting and grinding of various lifting lug eye welded to the east and west shear plates and 13 meters diaphragms. The ABF personnel have used cutting torch to cut the lifting lug eye 1/4" close to the plate then ground flush the remnants using a flapper disc. The removal and grinding of the lugs were ground smooth and deemed acceptable to the contract requirements. Four (4) lifting lug eyes removed and ground outside the east shear plate and four (4) on the west shear plate were completed. Four (4) lifting lug eyes from each diaphragm (7) on the 13 meters elevation were also removed and ground but already painted.
