Contract #: 04-0120F4Cty: SF/ALA Rte: 80 PM: 13.2/13.9File #: 1.28**WELDING INSPECTION REPORT****Resident Engineer:** Casey, William**Address:** 333 Burma Road**City:** Oakland, CA 94607**Report No:** WIR-026808**Date Inspected:** 02-Dec-2011**Project Name:** SAS Superstructure**OSM Arrival Time:** 700**Prime Contractor:** American Bridge/Fluor Enterprises, a JV**OSM Departure Time:** 1530**Contractor:** American Bridge/Fluor Enterprises, a JV**Location:** Job Site**CWI Name:** Steve Jensen**CWI Present:** Yes No**Inspected CWI report:** Yes No N/A**Rod Oven in Use:** Yes No N/A**Electrode to specification:** Yes No N/A**Weld Procedures Followed:** Yes No N/A**Qualified Welders:** Yes No N/A**Verified Joint Fit-up:** Yes No N/A**Approved Drawings:** Yes No N/A**Approved WPS:** Yes No N/A**Delayed / Cancelled:** Yes No N/A**Bridge No:** 34-0006**Component:** OBG Sections**Summary of Items Observed:**

WELDING INSPECTION REPORT

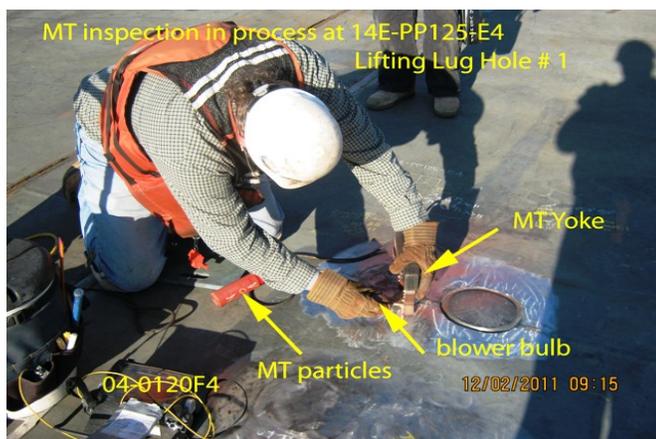
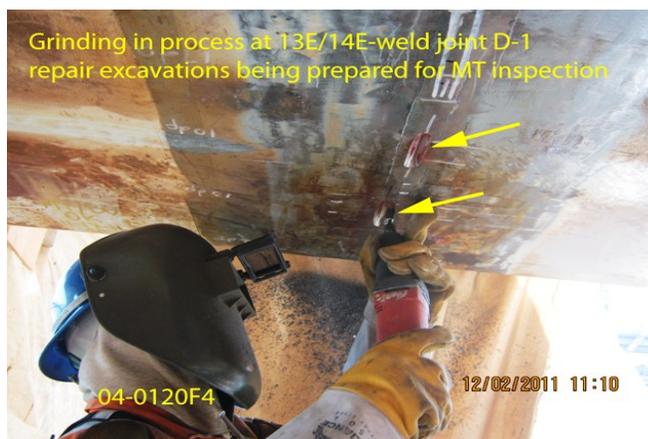
13E/14E-weld joint D-1 (SPCM) Repairs: This QA Inspector observed ABF welding personnel Wai Kitlai (#2953) using the carbon arc process and grinder to excavate 2 defects from the bottom of the OBG section. This QA Inspector observed QC Inspector Jesus Cayabyab monitoring the work. QC Inspector Jesus Cayabyab stated the base metal had been preheated as required prior to using the carbon arc process. This QA Inspector observed the defects original locations were Y-220 and Y-470. This QA Inspector observed QC Inspector Jesus Cayabyab perform a visual and MT inspection on each of the excavations after grinding. QC Inspector Jesus Cayabyab informed this QA Inspector the inspections had been accepted and observed the length, width and depth had been marked adjacent to each of the final excavations. This QA Inspector performed a visual verification and confirmed the following; excavation at Y-220 was 110 mm long, 29 mm wide and 17 mm deep, excavation at

Y-470 was 105 mm long, 19 mm wide and 10 mm deep. The work observed appeared to comply with Welding Procedure Specification (WPS) ABF-WPS-D15-1004 Repair. This QA Inspector observed a coil had been formed with the liquid induction heating equipment placed on the top side and over the repair area. This QA Inspector verified the preheat temperature to be greater than 325°F with a temperature indicating marker prior to the start of welding. This QA Inspector observed QC Inspector Jesus Cayabyab verify the following Shielded Metal Arc Welding (SMAW) parameters for ABF welding personnel Wai Kitlai (#2202); 132 amperes. This QA Inspector observed a 3.2 mm diameter E7018H4R electrode was being used in the overhead (4G) position. The welding observed appeared to comply with ABF-WPS-D15-1004 Repair being used by the QC Inspector. This QA Inspector periodically monitored and verified the welding activities at this location and observed at approximately 1400 hours the welding appeared to be completed. This QA Inspector confirmed with ABF welding foreman James Zhen and QC Inspector Jesus Cayabyab the induction heating equipment had been set for a temperature slightly greater than 450°F for 1-1/2 hours. The thickness of the plate on 13E is 30 mm and the thickness on 14E is 35 mm. The work observed appeared to comply with the contract requirements.
