**DEPARTMENT OF TRANSPORTATION**

Contract #: 04-0120F4Cty: SF/ALA Rte: 80 PM: 13.2/13.9File #: 1.28**WELDING INSPECTION REPORT****Resident Engineer:** Casey, William**Address:** 333 Burma Road**City:** Oakland, CA 94607**Report No:** WIR-026810**Date Inspected:** 02-Dec-2011**Project Name:** SAS Superstructure**OSM Arrival Time:** 700**Prime Contractor:** American Bridge/Fluor Enterprises, a JV**OSM Departure Time:** 1530**Contractor:** American Bridge/Fluor Enterprises, a JV**Location:** Job Site**CWI Name:** Listed below**CWI Present:** Yes No**Inspected CWI report:** Yes No N/A**Rod Oven in Use:** Yes No N/A**Electrode to specification:** Yes No N/A**Weld Procedures Followed:** Yes No N/A**Qualified Welders:** Yes No N/A**Verified Joint Fit-up:** Yes No N/A**Approved Drawings:** Yes No N/A**Approved WPS:** Yes No N/A**Delayed / Cancelled:** Yes No N/A**Bridge No:** 34-0006**Component:** S.A.S. components**Summary of Items Observed:**

- 1) OBG field splice welding at 13W/14W - D1
- 2) OBG field splice repair at 13W/14W - A2.2
- 3) OBG A deck, Vent Hole welding at 14W PP126.7 W2.5

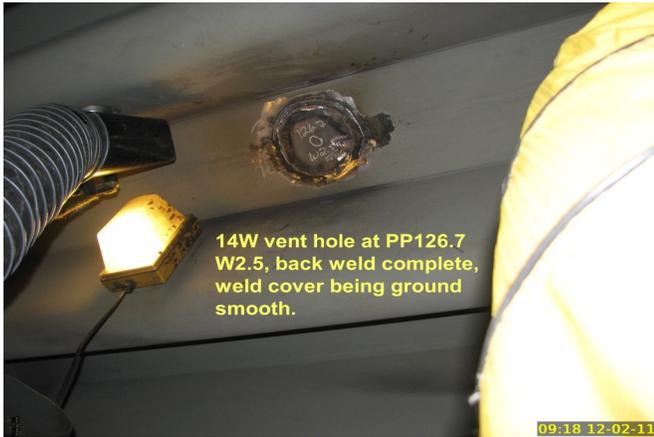
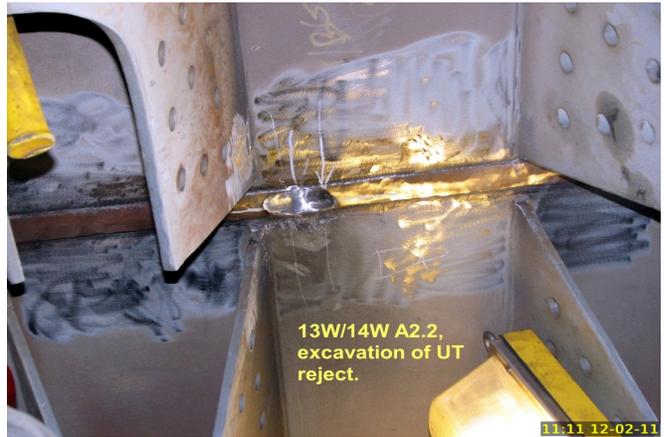
3) The QAI observed ABF welder Mike Jiminez, ID 4671, inside the OBG 14W at panel point (PP) 126.7 location W2.5. The QAI attempted to monitor the back welding of the vent hole patch that has been installed at this location. The QAI was informed that the welding is completed and the weld is being ground smooth. See the attached photo.
