Contract #: 04-0120F4Cty: SF/ALA Rte: 80 PM: 13.2/13.9File #: 1.28**WELDING INSPECTION REPORT****Resident Engineer:** Casey, William**Address:** 333 Burma Road**City:** Oakland, CA 94607**Report No:** WIR-026811**Date Inspected:** 03-Dec-2011**Project Name:** SAS Superstructure**OSM Arrival Time:** 700**Prime Contractor:** American Bridge/Fluor Enterprises, a JV**OSM Departure Time:** 1530**Contractor:** American Bridge/Fluor Enterprises, a JV**Location:** Jobsite

Bridge No: 34-0006**Summary of Items Observed:**

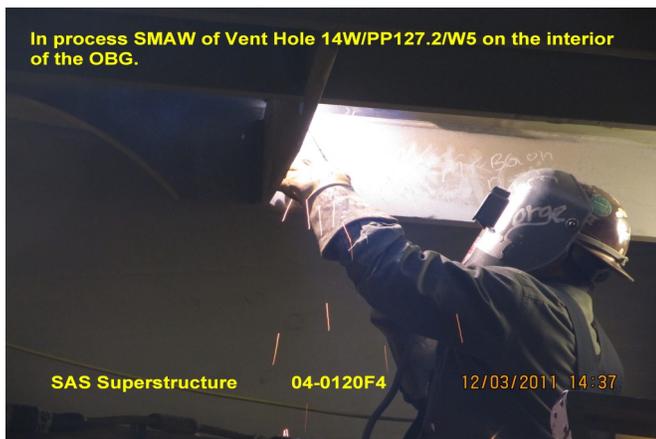
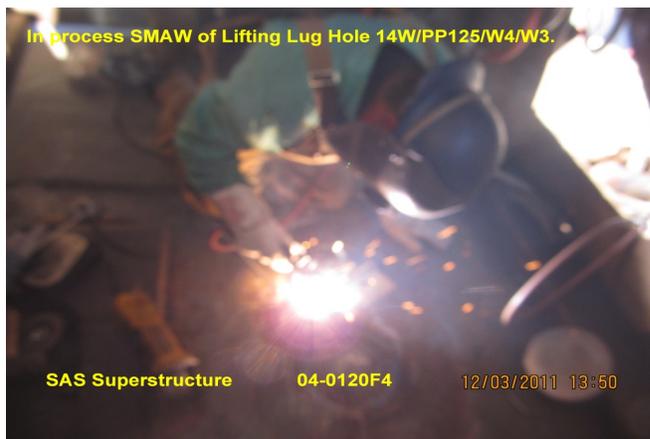
This QA Inspector randomly observed ABF welder Mike Jimenez performing the back-gouge operation on the interior of "A" deck Vent Hole 14W/PP127.2/W5. This QA Inspector observed QC Inspector Sal Merino perform a Magnetic Particle Inspection (MT) of the back gouge to determine the soundness of the metal. Upon completion of the testing this QA Inspector verified that no rejectable indications were present. This QA Inspector made random observations of ABF welder Mike Jimenez (ID 4671) perform the Shielded Metal Arc Welding process (SMAW) in the (4G) overhead position. This QA Inspector observed QC Inspector Sal Merino measure the pre-heat temperature to verify a minimum of 10°C was achieved. This QA Inspector also observed the QC Inspector monitoring the welding and verifying that the parameters were in compliance pertaining to

This QA Inspector randomly observed ABF welder Mike Jimenez (ID 4671) performing the Shielded Metal Arc Welding (SMAW) process in the (4G) overhead position on “A” deck vent hole 14W/PP126.2/W2.8. This QA Inspector observed QC Inspector Sal Merino verify that the preheat temperature was at the minimum of 10 degrees C and that the welding parameters; Amps=123-3.2 mm electrode were in accordance with the above mentioned WPS. This QA Inspector made subsequent observations throughout the shift to monitor quality and noted that the work was completed on this date and appeared to be in general compliance with the contract specifications.

This QA Inspector observed QC Inspector Sal Merino utilize a Bridge Cam Gage to measure the fit-up of the 20 mm plate in the BU-4a joint on lifting lug hole 14W/PP125/W4/W3. This QA Inspector verified the fit-up as acceptable and employed a 65°C Tempilstik to ensure the minimum pre-heat temperature had been achieved. This QA Inspector randomly observed ABF welder Salvador Sandoval performing the Shielded Metal Arc Welding (SMAW) process in the (1G) flat position and observed the QC Inspector verify the welding parameters were in
