Contract #: 04-0120F4Cty: SF/ALA Rte: 80 PM: 13.2/13.9File #: 1.28**WELDING INSPECTION REPORT****Resident Engineer:** Casey, William**Address:** 333 Burma Road**City:** Oakland, CA 94607**Report No:** WIR-026826**Date Inspected:** 06-Dec-2011**Project Name:** SAS Superstructure**OSM Arrival Time:** 700**Prime Contractor:** American Bridge/Fluor Enterprises, a JV**OSM Departure Time:** 1530**Contractor:** American Bridge/Fluor Enterprises, a JV**Location:** Job Site

WELDING INSPECTION REPORT

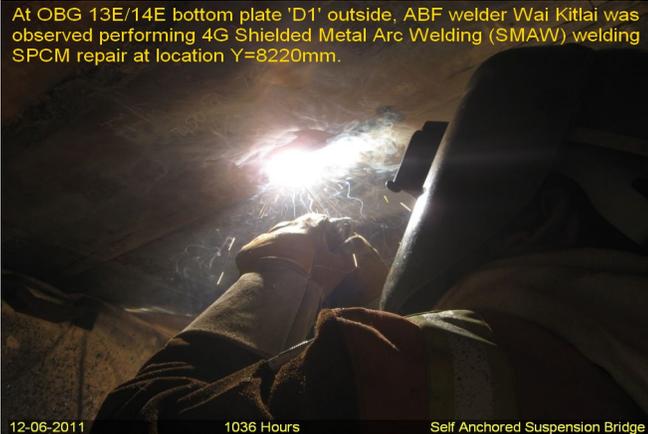
At OBG 13E/14E bottom plate 'D1' outside, ABF welder Wai Kitlai was observed performing 4G Shielded Metal Arc Welding (SMAW) welding SPCM repair at location Y=8220mm.

At OBG 13E/14E bottom plate 'D1' outside, QA randomly observed ABF/JV qualified welder Wai Kitlai perform CJP groove welding repair. The welder was observed welding in the 4G (overhead) position utilizing Shielded Metal Arc Welding (SMAW) with 1/8" diameter E7018H4R electrode implementing welding procedure ABF-WPS-D15-1004-Repair for the Seismic Performance Critical Member (SPCM) butt joint. The repair excavations were preheated to more than 325 degrees Fahrenheit using Miller Proheat 35 Heating Induction System with blanket located at the opposite side of the weld joint being welded. During the shift, ABF QC Fred Von Hoff was noted monitoring the welder with 130 amperes measured current on the 1/8" diameter E7018H4R electrode. The following first time repairs were noted excavated and being repaired. The completely welded repairs were Post Weld Heat Treated (PWHT) at 450 degrees Fahrenheit for one and a half (1 1/2) hour as required using the Miller Proheat 35 Induction Heating System.

Location	Y-dimension	Length	Width	Depth	Remarks
1. 13E/14E bot. plate 'D1'	7450mm		120mm	25mm	22 Completed
2. 13E/14E bot. plate 'D1'	7550mm		95mm	25mm	16 Completed
3. 13E/14E bot. plate 'D1'	8220mm		180mm	25mm	22 In progress

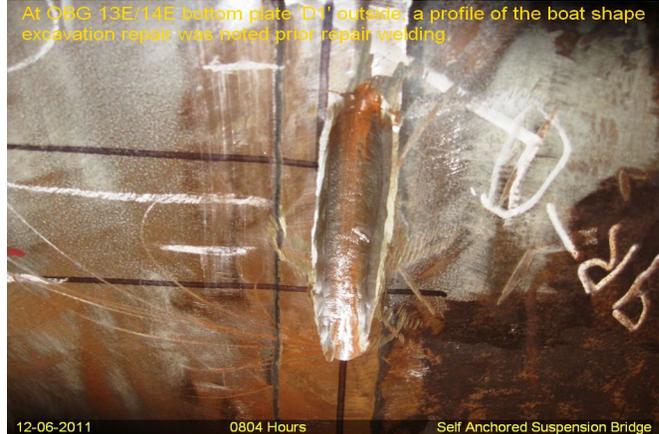
At OBG 13E/14E bottom plate 'D1' outside, a profile of the boat shape excavation repair was noted prior repair welding.

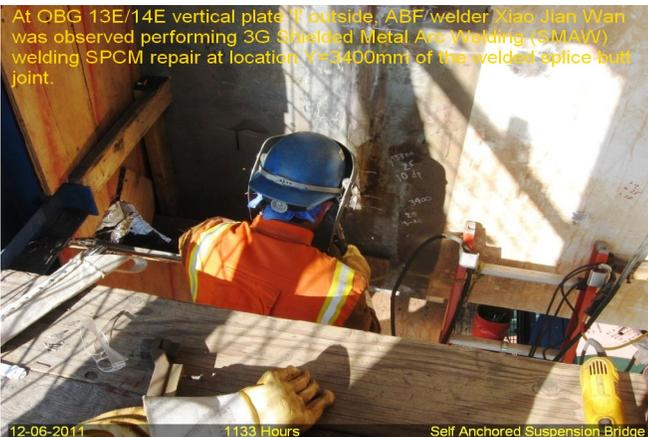
At OBG 13E/14E vertical plate 'I' outside, ABF welder Xiao Jian Wan was observed performing 3G Shielded Metal Arc Welding (SMAW) welding SPCM repair at location Y=3400mm of the welded splice butt joint.

At OBG 13E/14E vertical plate 'I' outside, QA randomly observed ABF/JV qualified welder Xiao Jian Wan perform CJP groove welding repair. The welder was observed welding in the 3G (vertical) position utilizing Shielded Metal Arc Welding (SMAW) with 1/8" diameter E7018H4R electrode implementing welding procedure ABF-WPS-D15-1004-Repair for the Seismic Performance Critical Member (SPCM) butt joint. The repair excavations were preheated to more than 325 degrees Fahrenheit using Miller Proheat 35 Heating Induction System with blanket located at the opposite side of the weld joint being welded. During the shift, ABF QC Fred Von Hoff was noted monitoring the welder with 126 amperes measured current on the 1/8" diameter E7018H4R electrode. The following first time repairs were noted excavated and being repaired. The completely welded repairs were Post Weld Heat Treated (PWHT) at 450 degrees Fahrenheit for one (1) hour as required using the Miller Proheat 35 Induction Heating System.

Location	Y-dimension	Length	Width	Depth	Remarks
1. 13E/14E vert. plate 'I'	2710mm		125mm	25mm	12 Completed
2. 13E/14E vert. plate 'I'	3300mm		110mm	25mm	12 In progress
3. 13E/14E vert. plate 'I'	3400mm		110mm	25mm	12 Completed

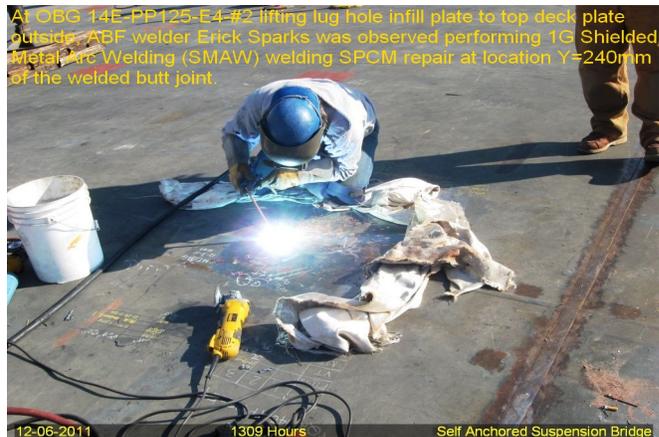
At OBG 14E-PP125-E4-#2 lifting lug hole infill plate to top deck plate outside, ABF welder Erick Sparks was observed performing 1G Shielded Metal Arc Welding (SMAW) welding SPCM repair at location Y=240mm of the welded butt joint.

At OBG 14E-PP125-E4-#1 and #2 lifting lug hole infill plate to top deck plate outside, QA randomly observed ABF/JV qualified welder Erick Sparks perform CJP groove welding repair. The welder was observed welding in the 1G (flat) position utilizing Shielded Metal Arc Welding (SMAW) with 1/8" diameter E7018H4R electrode implementing welding procedure ABF-WPS-D15-1004-Repair for the Seismic Performance Critical Member (SPCM) butt joint. Prior the repair excavation, the weld butt joint and adjacent base metal were preheated to more than 225 degrees Fahrenheit using propane gas torch. After the excavation and subsequent smooth grinding, ABF QC Salvador Merino was observed performing Magnetic Particle Testing (MT) on the boat shape excavations with no significant defects noted during the test. The excavations and adjacent base metal were again preheated to more than 325 degrees Fahrenheit prior welding. ABF QC William Sherwood was noted monitoring the welder at the time of the repair. The following repair excavations were completely welded before the end of the shift and were Post Weld Heat Treated (PWHT) at 450 degrees Fahrenheit for one (1) hour as required using the Miller Proheat 35 Induction Heating System.

Location	Y-dimension	Length	Width	Depth	Remarks
1.	14E-PP125-E4-#1	290mm	60mm	20mm	13mm	Completed
2.	14E-PP125-E4-#2	240mm	50mm	15mm	13mm	Completed
3.	14E-PP125-E4-#2	550mm	50mm	15mm	15mm	Completed
