DEPARTMENT OF TRANSPORTATION

Quality Assurance and Source Inspection

Contract #: 04-0120F4Cty: SF/ALA Rte: 80 PM: 13.2/13.9File #: 1x.28**WELDING INSPECTION REPORT****Resident Engineer:** Casey, William**Address:** 333 Burma Road**City:** Oakland, CA 94607**Report No:** WIR-026832**Date Inspected:** 09-Dec-2011**Project Name:** SAS Superstructure**OSM Arrival Time:** 630**Prime Contractor:** American Bridge/Fluor Enterprises, a JV**OSM Departure Time:** 1530**Contractor:** American Bridge/Fluor Enterprises, a JV**Location:** Jobsite**CWI Name:** Bernie Docena**CWI Present:** Yes No**Inspected CWI report:** Yes No N/A**Rod Oven in Use:** Yes No N/A**Electrode to specification:** Yes No N/A**Weld Procedures Followed:** Yes No N/A**Qualified Welders:** Yes No N/A**Verified Joint Fit-up:** Yes No N/A**Approved Drawings:** Yes No N/A**Approved WPS:** Yes No N/A**Delayed / Cancelled:** Yes No N/A**Bridge No:** 34-0006**Component:** BikePath - Skyway**Summary of Items Observed:**

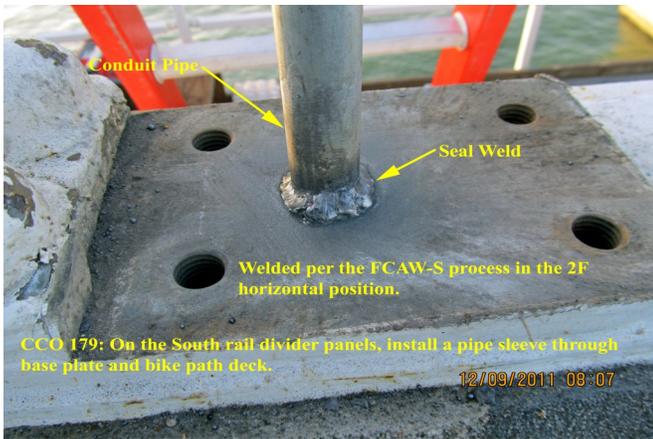
This QA Inspector randomly observed ABF welder Mr. Jason Collins (Welder ID 8128) performing the seal weld operation after the pipe sleeve is installed on the top and bottom plate of the bike path divider panels per the Flux Cored Arc Welding (FCAW) self shielding process in the (2F) horizontal position on the top plate and (4F) overhead position on the bottom plate. The seal weld operation was performed between Pier 14E to Pier 13E. This QA Inspector observed QC Inspector Mr. Bernie Docena verify prior to the start of the seal weld operation that the preheat temperature of 70 degrees F was established and afterwards verified that the welding parameters (Amps, Volts and Travel Speed) were in accordance with WPS D11-F2201 using the E71T11 electrode - (.030") diameter electrode.

After the seal weld operation was completed connecting the pipe sleeve to the top and bottom plates of the Bike path south side divider panels between Pier 14E and Pier 13E (20 locations), this QA Inspector observed QC Inspector Mr. Bernie Docena; perform a visual inspection of the seal weld to verify the weld quality. The seal weld quality visually appeared to be in general compliance with AWS D1.5-2002 Section 3.6 and 6.26.
