**DEPARTMENT OF TRANSPORTATION**

Contract #: 04-0120F4Cty: SF/ALA Rte: 80 PM: 13.2/13.9File #: 1.28**WELDING INSPECTION REPORT****Resident Engineer:** Casey, William**Address:** 333 Burma Road**City:** Oakland, CA 94607**Report No:** WIR-026848**Date Inspected:** 10-Dec-2011**Project Name:** SAS Superstructure**OSM Arrival Time:** 700**Prime Contractor:** American Bridge/Fluor Enterprises, a JV**OSM Departure Time:** 1530**Contractor:** American Bridge/Fluor Enterprises, a JV**Location:** Jobsite

**Bridge No:** 34-0006**Summary of Items Observed:**

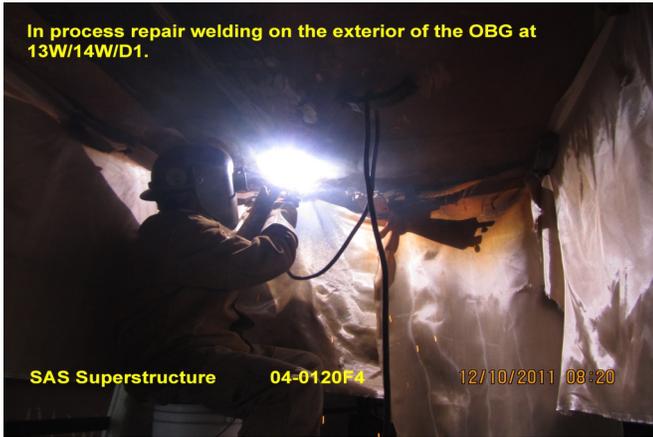
This QA Inspector observed ABF welding personnel performing back-gouge operations of ultrasonic rejectable indications on "D1" on the exterior of the OBG location 13W/14W. The dimensions of the excavations are listed below. This QA Inspector observed QC Inspector William Sherwood perform a Magnetic Particle Inspection (MT) of the excavations to determine the soundness of the metal. Upon completion of the testing this QA Inspector verified that no rejectable indications were present.

This QA Inspector randomly observed ABF welder James Zhen (ID 6001) performing the repair welding operation of ultrasonic indication #13 as per the Shielded Metal Arc Welding (SMAW) process in the (4G) overhead position on "D1" Bottom Plate Splice 13W/14W. The dimensions of the excavation were as follows y+ 720 (length; 1230mm, width; 40mm, depth; 19). This QA Inspector observed QC Inspector William Sherwood

This QA Inspector noted the QC Manager had submitted a Critical Weld Repair Procedure (CWRP) and a response was pending in reference to rejectable indication #13.

This QA Inspector randomly observed ABF welding personnel James Zhen, Wai Kit Lai and Jin Pei Wang performing the repair welding operations of nine (9) ultrasonic indications as per the Shielded Metal Arc Welding (SMAW) process in the (4G) overhead position on "D1" Bottom Plate Splice 13W/14W. This QA Inspector observed the use of E7018-H4R electrodes and QC Inspector William Sherwood verify the preheat temperature and that the welding parameters were in accordance with ABF-WPS- D1.5-1004- Repair. The welding parameters observed at this location appeared to be in general compliance with approved WPS and the contract specifications.
