Contract #: 04-0120F4Cty: SF/ALA Rte: 80 PM: 13.2/13.9File #: 1x.28**WELDING INSPECTION REPORT****Resident Engineer:** Casey, William**Address:** 333 Burma Road**City:** Oakland, CA 94607**Report No:** WIR-026850**Date Inspected:** 12-Dec-2011**Project Name:** SAS Superstructure**OSM Arrival Time:** 630**Prime Contractor:** American Bridge/Fluor Enterprises, a JV**OSM Departure Time:** 1630**Contractor:** American Bridge/Fluor Enterprises, a JV**Location:** Job Site**CWI Name:** Bernie Docena**CWI Present:** Yes No**Inspected CWI report:** Yes No N/A**Rod Oven in Use:** Yes No N/A**Electrode to specification:** Yes No N/A**Weld Procedures Followed:** Yes No N/A**Qualified Welders:** Yes No N/A**Verified Joint Fit-up:** Yes No N/A**Approved Drawings:** Yes No N/A**Approved WPS:** Yes No N/A**Delayed / Cancelled:** Yes No N/A**Bridge No:** 34-0006**Component:** Bike Path - Skyway**Summary of Items Observed:**

WELDING INSPECTION REPORT

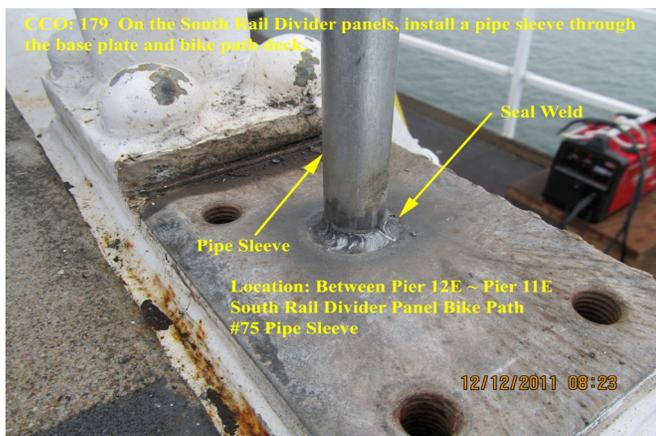
This QA Inspector randomly observed ABF welder Mr. Jason Collins (Welder ID 8128) performing the seal weld operation after the pipe sleeve is installed on the top and bottom plate of the bike path divider panels per the Flux Cored Arc Welding (FCAW) self shielding process in the (2F) horizontal position on the top plate and (4F) overhead position on the bottom plate. The seal weld operation was performed between Pier 12E to Pier 11E. This QA Inspector observed QC Inspector Mr. Bernie Docena verify prior to the start of the seal weld operation that the preheat temperature of 70 degrees F was established and afterwards verified that the welding parameters (Amps, Volts and Travel Speed) were in accordance with WPS D11-F2201 using the E71T11 electrode - (.030") diameter electrode.

After the seal weld operation was completed connecting the pipe sleeve to the top and bottom plates of the Bike path south side divider panels between Pier 12E and Pier 11E (26 locations - Pipe Sleeve #75 ~ #101), this QA Inspector observed QC Inspector Mr. Bernie Docena; perform a visual inspection of the seal weld to verify the weld quality. The seal weld quality visually appeared to be in general compliance with AWS D1.5-2002 Section 3.

Afterwards, this QA Inspector also witnessed the brush application of inorganic zinc rich primer Interzinc 52 after the weld and surrounding base metal were cleaned in accordance with SSPC-SP3 Power Tool Cleaning.
