DEPARTMENT OF TRANSPORTATION

Contract #: 04-0120F4Cty: SF/ALA Rte: 80 PM: 13.2/13.9File #: 1.28**WELDING INSPECTION REPORT****Resident Engineer:** Casey, William**Address:** 333 Burma Road**City:** Oakland, CA 94607**Report No:** WIR-026852**Date Inspected:** 08-Dec-2011**Project Name:** SAS Superstructure**OSM Arrival Time:** 700**Prime Contractor:** American Bridge/Fluor Enterprises, a JV**OSM Departure Time:** 1730**Contractor:** American Bridge/Fluor Enterprises, a JV**Location:** Job Site

WELDING INSPECTION REPORT

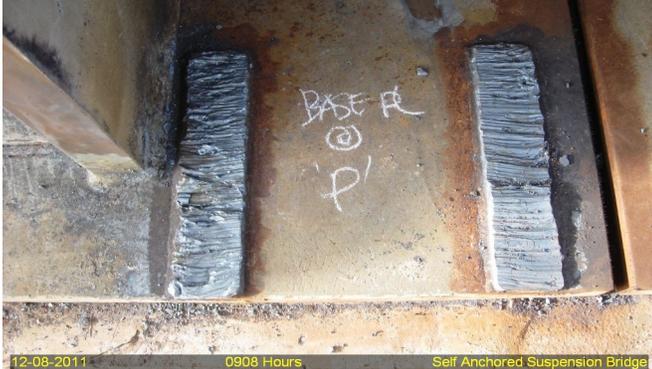
At Tower Base plate, ABF personnel have cut the temporary welded jacking lug to 1/4" above the plate and to grind it flush using the flapper disc grinder.

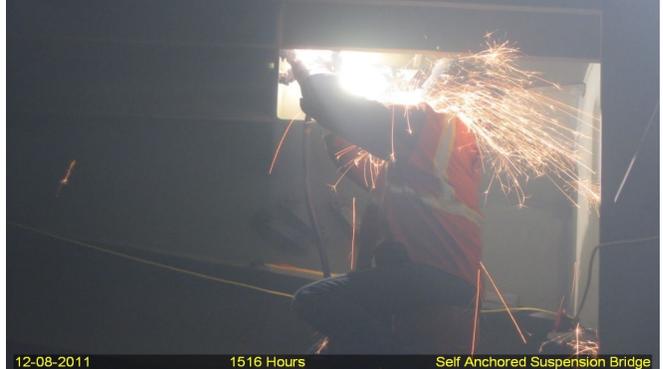
At OBG 14E-PP127.2-E5 vent hole infill plate to top deck plate inside, ABF welder Erick Sparks was observed performing carbon arc gouging the bottom of the welded from the top butt joint.

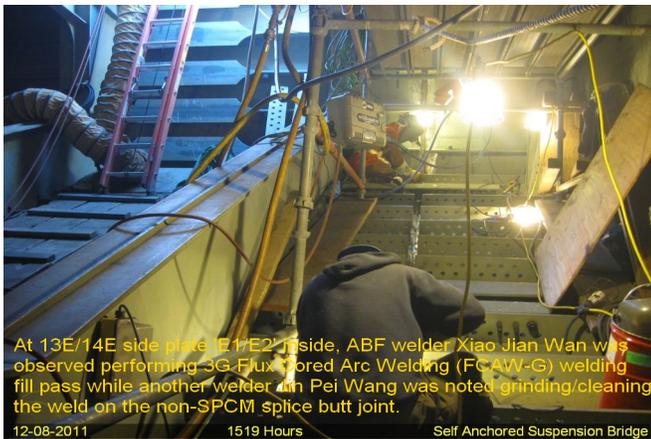
At OBG 13E/14E side plate 'E' inside, QA randomly observed ABF/JV qualified welder Xiao Jian Wan continuing to perform CJP groove (splice) welding root then on the splice butt joint. The welder was observed perform manual welding in the 3G (vertical) position utilizing a dual shield Flux Cored Arc Welding (FCAW-G) with E71T-1M, 1/16" diameter wire electrode and implementing Caltrans approved Welding Procedure Specification (WPS) ABF-WPS-D15-3042B-1. The joint being welded has a single V-groove butt joint with

backing bar that will be removed then back welded. The splice joint was preheated and maintained to greater than 150 degrees Fahrenheit using Miller Proheat 35 Induction Heating System heater blankets located at the opposite side of the plate prior/during welding. During welding, ABF Quality Control (QC) Fred Von Hoff was noted monitoring the welding parameters of the welder with measured working current of 270 amperes and working voltage of 25.2 volts. At the end of the shift, fill pass welding on the splice butt joint was still continuing and should remain tomorrow.
