DEPARTMENT OF TRANSPORTATION

Contract #: 04-0120F4Cty: SF/ALA Rte: 80 PM: 13.2/13.9File #: 1.28**WELDING INSPECTION REPORT****Resident Engineer:** Casey, William**Address:** 333 Burma Road**City:** Oakland, CA 94607**Report No:** WIR-026856**Date Inspected:** 12-Dec-2011**Project Name:** SAS Superstructure**OSM Arrival Time:** 700**Prime Contractor:** American Bridge/Fluor Enterprises, a JV**OSM Departure Time:** 1730**Contractor:** American Bridge/Fluor Enterprises, a JV**Location:** Job Site

WELDING INSPECTION REPORT

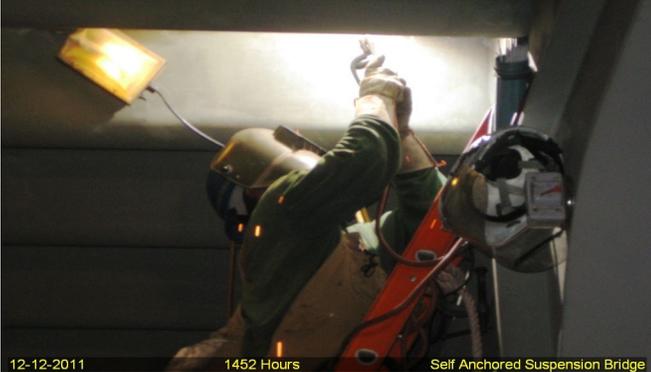
At OBG 11E-PP100-E3-#4 lifting lug hole infill plate to top deck plate inside, AB welder Salvador Sandoval was observed performing 4G Shielded Metal Arc Welding (SMAW) back welding fill pass on butt joint.

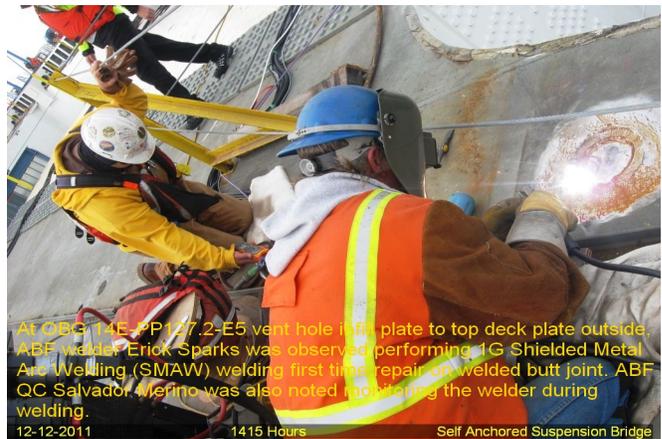
At OBG 14E-PP127.2-E5 vent hole infill plate to top deck plate outside, QA randomly observed ABF/JV qualified welder Erick Sparks continuing to perform CJP groove welding repair. The welder was observed welding in the 1G (flat) position utilizing Shielded Metal Arc Welding (SMAW) with 1/8" diameter E7018H4R electrode implementing welding procedure ABF-WPS-D15-1004-Repair for the Seismic Performance Critical Member (SPCM) butt joint. Prior the repair excavation, the weld butt joint and adjacent base metal were preheated to more than 225 degrees Fahrenheit using propane gas torch. After the excavation and subsequent smooth grinding, ABF QC Salvador Merino was observed performing Magnetic Particle Testing (MT) on the boat shape excavations with no significant defects noted during the test. The excavations and adjacent base metal were again preheated to more than 325 degrees Fahrenheit prior welding. ABF QC Salvador Merino was noted monitoring the welder at the time of the repair with measured working current of 130 amperes on a 1/8" diameter E7018H4R electrode. The welding repair located at Y=400 having dimensions of 80mm long x 20mm wide x 13mm deep was completely welded during the shift and was Post Weld Heat Treated (PWHT) at 450 degrees Fahrenheit for one (1) hour as required using the Miller Proheat 35 Induction Heating System.

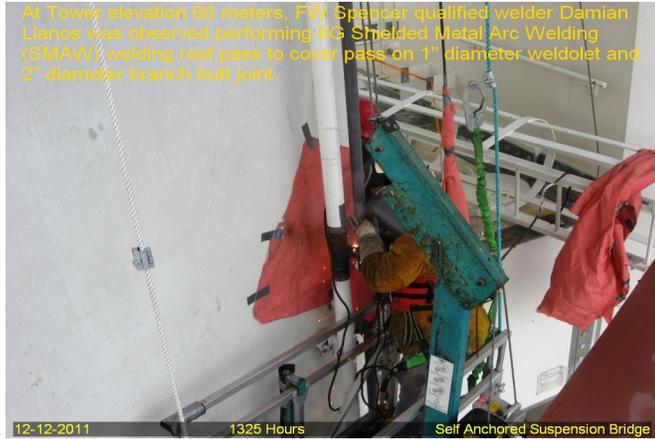
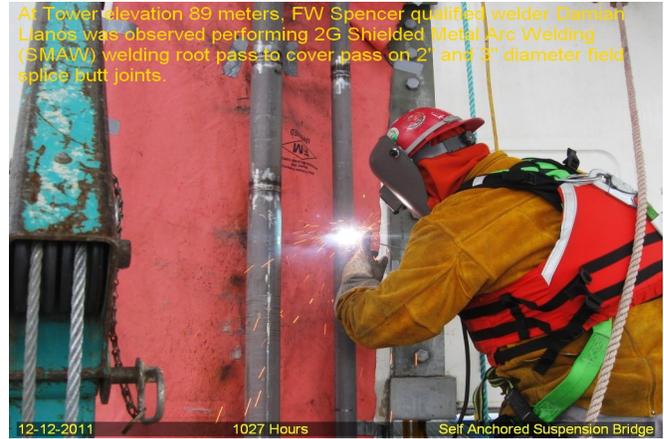
At Tower South shaft elevation 89 meters, this QA randomly observed FW Spencer qualified welder Damian Llanos ID-6645 perform Complete Joint Penetration (CJP) 2G (horizontal position) Shielded Metal Arc Welding (SMAW) welding root pass to cover pass on the 2.0" and 3" diameter domestic water and air lines respectively. The system lines being welded are field splices along the tower elevation. The welder was noted welding the root pass with 3/32" diameter E6010 electrode and followed by fill pass to cover pass using 3/32" diameter E7018H4R electrode implementing Caltrans approved procedure FW Spencer WPS 1-12-1. The welder was noted preheating and removing the moisture of the joint using a portable propane gas torch prior welding. During welding, ABF QC Steve Jensen was noted monitoring the parameters of the welder. During the shift, two (2) field splices on each line (2" & 3") were completed and visually accepted by QC. This QA performed VT verification on the completed weld splices and they appear in compliance to the Contract requirements. After the welding completion of the butt joints at elevation 89 meters, the welder has moved to elevation 66 meters and performed 6G SMAW welding on 1" diameter weldolet branch for the 2" diameter domestic water line and 2" butt joint on a 3" x 2" reducing tee for the 3" diameter air line. Both the joints were completed at the end of the shift.
