DEPARTMENT OF TRANSPORTATION

Contract #: 04-0120F4Cty: SF/ALA Rte: 80 PM: 13.2/13.9File #: 1.28**WELDING INSPECTION REPORT****Resident Engineer:** Casey, William**Address:** 333 Burma Road**City:** Oakland, CA 94607**Report No:** WIR-026897**Date Inspected:** 16-Dec-2011**Project Name:** SAS Superstructure**OSM Arrival Time:** 700**Prime Contractor:** American Bridge/Fluor Enterprises, a JV**OSM Departure Time:** 1530**Contractor:** American Bridge/Fluor Enterprises, a JV**Location:** Job Site

WELDING INSPECTION REPORT

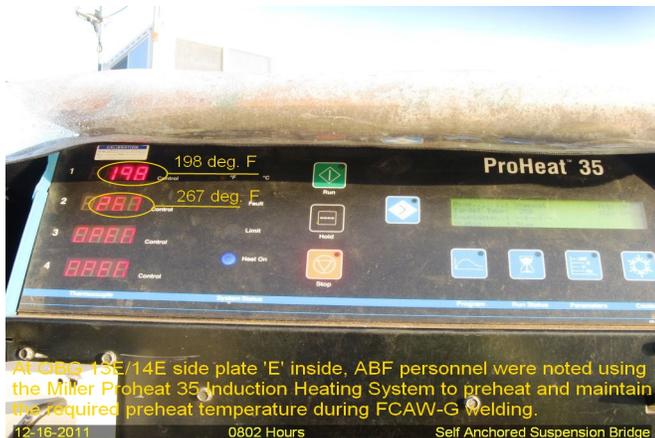
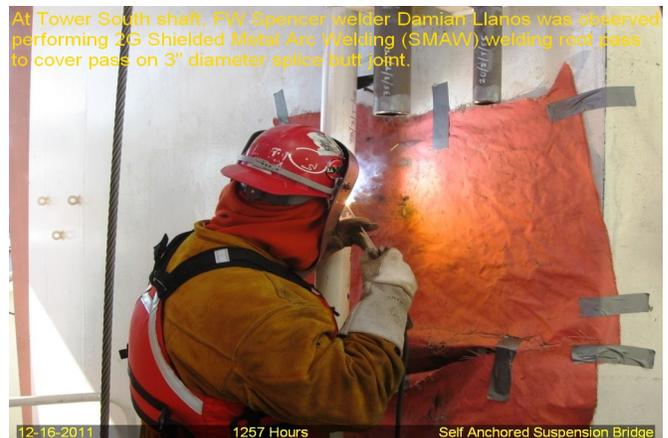
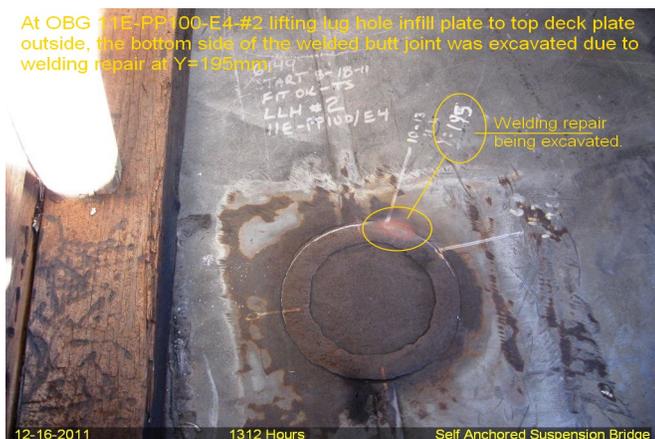
At Tower South shaft, this QA randomly observed FW Spencer qualified welder Damian Llanos ID-6645 continuing to perform Complete Joint Penetration (CJP) 2G (horizontal position) Shielded Metal Arc Welding (SMAW) welding root pass to cover pass on the 3" diameter domestic water line. The system line being welded is a field branch along the tower elevation. The welder was noted welding the root pass with 3/32" diameter E6010 electrode and followed by fill pass to cover pass using 3/32" diameter E7018H4R electrode implementing Caltrans approved procedure FW Spencer WPS 1-12-1. The welder was noted preheating and removing the moisture of the joint using a portable propane gas torch prior welding. During welding, ABF QC Steve Jensen was noted monitoring the parameters of the welder. At the end of the shift, the welder has completed the following 3" diameter butt joints and inspected by QC. The butt joints were also VT verified by this QA;

1. 37/3/T/53 53 3" pipe field splice at 3" x 3" x 2" reducing tee
2. 38/3/T/48 48 3" pipe field splice
3. 39/3/T/47 47 3" pipe field splice
