DEPARTMENT OF TRANSPORTATION

Contract #: 04-0120F4Cty: SF/ALA Rte: 80 PM: 13.2/13.9File #: 1.28**WELDING INSPECTION REPORT****Resident Engineer:** Casey, William**Address:** 333 Burma Road**City:** Oakland, CA 94607**Report No:** WIR-026901**Date Inspected:** 17-Dec-2011**Project Name:** SAS Superstructure**OSM Arrival Time:** 700**Prime Contractor:** American Bridge/Fluor Enterprises, a JV**OSM Departure Time:** 1530**Contractor:** American Bridge/Fluor Enterprises, a JV**Location:** Job Site**CWI Name:** Fred Von Hoff**CWI Present:** Yes No**Inspected CWI report:** Yes No N/A**Rod Oven in Use:** Yes No N/A**Electrode to specification:** Yes No N/A**Weld Procedures Followed:** Yes No N/A**Qualified Welders:** Yes No N/A**Verified Joint Fit-up:** Yes No N/A**Approved Drawings:** Yes No N/A**Approved WPS:** Yes No N/A**Delayed / Cancelled:** Yes No N/A**Bridge No:** 34-0006**Component:** SAS OBG**Summary of Items Observed:**

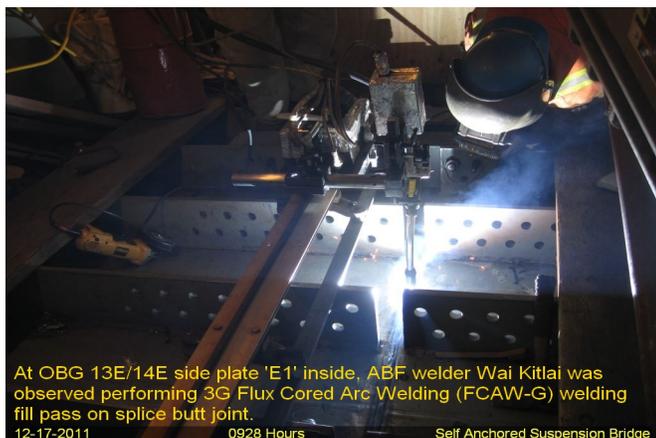
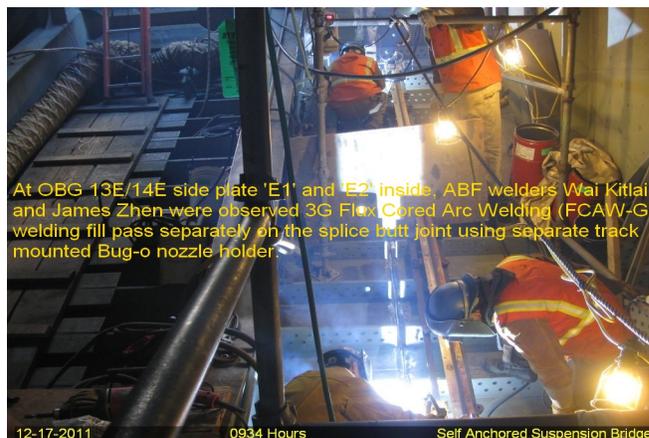
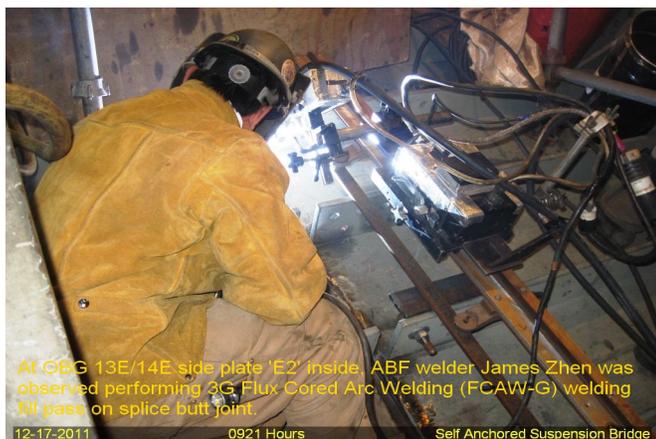
At OBG 13E/14E side plate 'E1' inside, QA randomly observed ABF/JV qualified welder Wai Kitlai continuing to perform CJP groove (splice) welding fill pass on the splice butt joint. The welder was observed perform automatic welding in the 3G (vertical) position utilizing a dual shield Flux Cored Arc Welding (FCAW-G) with E71T-1M, 1/16" diameter wire electrode and implementing Caltrans approved Welding Procedure Specification (WPS) ABF-WPS-D15-3042B-1. The joint being welded has a single V-groove butt joint with backing bar that will be removed then back welded. The splice joint was preheated and maintained to greater than 150 degrees Fahrenheit using Miller Proheat 35 Induction Heating System heater blankets located at the opposite side of the plate prior/during welding. During welding, ABF Quality Control (QC) Fred Von Hof was noted monitoring the welding parameters of the welder with measured working current of 260 amperes and working voltage of 24.3 volts. At the end of the shift, fill pass welding on the splice butt joint was still continuing and should remain Monday.

At OBG 13E/14E side plate 'E2' inside, QA randomly observed ABF/JV qualified welder James Zhen continuing to perform CJP groove (splice) welding fill pass on the splice butt joint. The welder was observed perform automatic welding in the 3G (vertical) position utilizing a dual shield Flux Cored Arc Welding (FCAW-G) with E71T-1M, 1/16" diameter wire electrode and implementing Caltrans approved Welding Procedure Specification (WPS) ABF-WPS-D15-3042B-1. The joint being welded has a single V-groove butt joint with backing bar that

will be removed then back welded. The splice joint was preheated and maintained to greater than 150 degrees Fahrenheit using Miller Proheat 35 Induction Heating System heater blankets located at the opposite side of the plate prior/during welding. During welding, ABF Quality Control (QC) Fred Von Hof was noted monitoring the welding parameters of the welder with measured working current of 265 amperes and working voltage of 24.1 volts. At the end of the shift, fill pass welding on the splice butt joint was still continuing and should remain Monday.
