Quality Assurance and Source Inspection

Contract #: 04-0120F4Cty: SF/ALA Rte: 80 PM: 13.2/13.9File #: 1x.28**WELDING INSPECTION REPORT****Resident Engineer:** Casey, William**Address:** 333 Burma Road**City:** Oakland, CA 94607**Report No:** WIR-026928**Date Inspected:** 19-Dec-2011**Project Name:** SAS Superstructure**OSM Arrival Time:** 630**Prime Contractor:** American Bridge/Fluor Enterprises, a JV**OSM Departure Time:** 1630**Contractor:** American Bridge/Fluor Enterprises, a JV**Location:** Job Site**CWI Name:** Bernie Docena**CWI Present:** Yes No**Inspected CWI report:** Yes No N/A**Rod Oven in Use:** Yes No N/A**Electrode to specification:** Yes No N/A**Weld Procedures Followed:** Yes No N/A**Qualified Welders:** Yes No N/A**Verified Joint Fit-up:** Yes No N/A**Approved Drawings:** Yes No N/A**Approved WPS:** Yes No N/A**Delayed / Cancelled:** Yes No N/A**Bridge No:** 34-0006**Component:** Bike Path Box Panel - Skyway**Summary of Items Observed:**

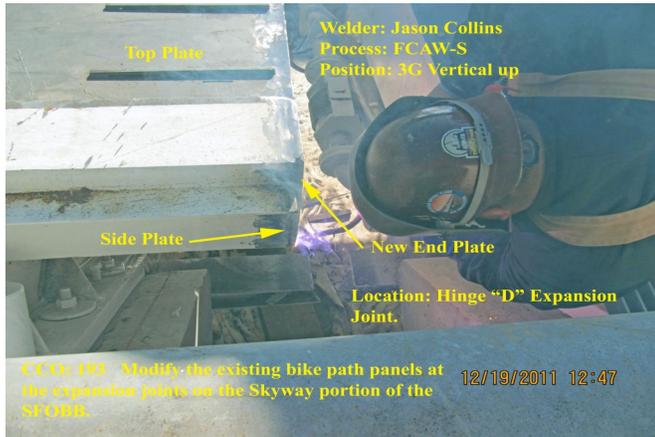
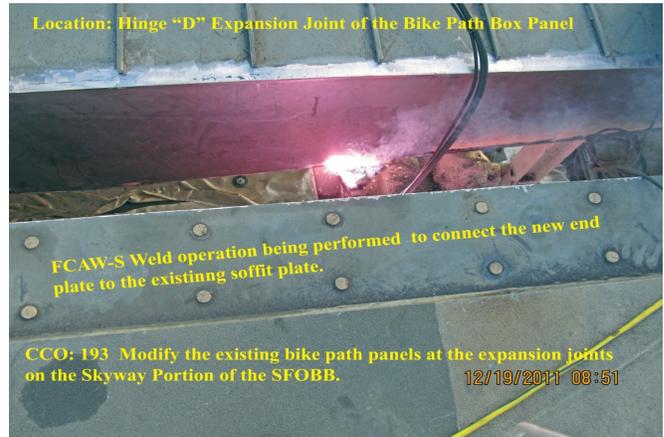
This QA Inspector randomly observed ABF welder Mr. Jason Collins (Welder ID 8128) performing the root, fill, and cover pass weld operation on a partial-joint-penetration (PJP) groove weld per the Flux Cored Arc Welding (FCAW-S) self shielding process in the (1G) and (3G) flat and vertical position connecting the new end plate to the existing top plate of the bike path panel at expansion joint Hinge "D" as per ABF Submittal no. 2549R1 of Contract Change Order (CCO) 193.

Note: At the Expansion Joint Hinge "D" This QA Inspector previously observed ABF personnel cut back the top and side skin plate and diaphragm plate using an oxyacetylene cutting torch on a track system and also observed the ABF personnel use a mechanical cutting blade on the existing soffit plate of the bike path box panel. The cut back distance was measured at 116 mm as per Contract plan sheet number 1164S7 and ABF Submittal number 2549R1. The new end plate has been fit-up and the welding operation is being performed on this date as mentioned above.
