DEPARTMENT OF TRANSPORTATION

Contract #: 04-0120F4Cty: SF/ALA Rte: 80 PM: 13.2/13.9File #: 99.28**WELDING INSPECTION REPORT****Resident Engineer:** Casey, William**Address:** 333 Burma Road**City:** Oakland, CA 94607**Report No:** WIR-026929**Date Inspected:** 14-Dec-2011**Project Name:** SAS Superstructure**OSM Arrival Time:** 800**Prime Contractor:** American Bridge/Fluor Enterprises, a JV**OSM Departure Time:** 1630**Contractor:** Watson Bowman ACME**Location:** Buffalo, NY**CWI Name:** Reno Davis, John Crabtree**CWI Present:** Yes No**Inspected CWI report:** Yes No N/A**Rod Oven in Use:** Yes No N/A**Electrode to specification:** Yes No N/A**Weld Procedures Followed:** Yes No N/A**Qualified Welders:** Yes No N/A**Verified Joint Fit-up:** Yes No N/A**Approved Drawings:** Yes No N/A**Approved WPS:** Yes No N/A**Delayed / Cancelled:** Yes No N/A**Bridge No:** 34-0006**Component:** Seismic Joint Hinge A**Summary of Items Observed:**

WELDING INSPECTION REPORT

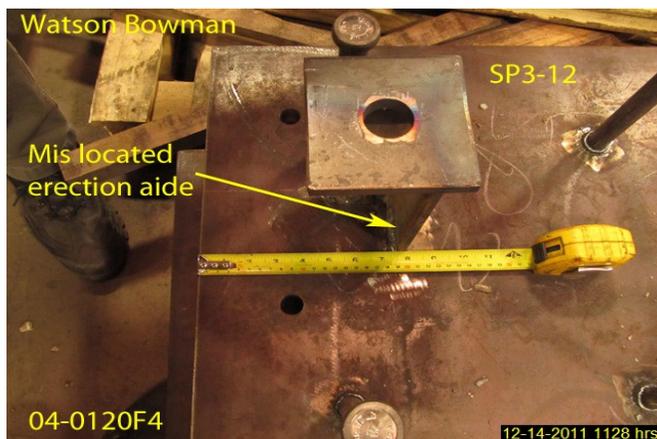
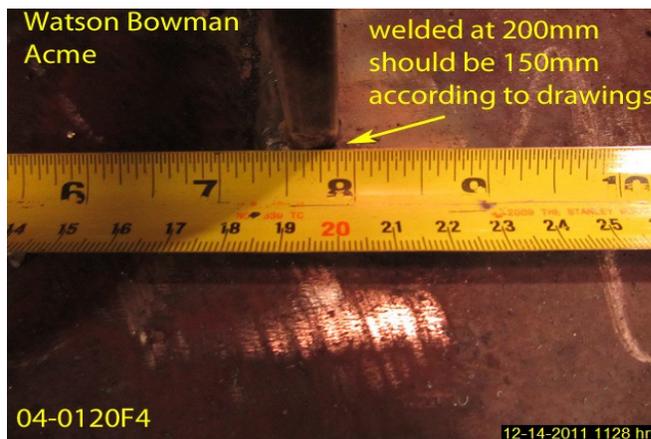
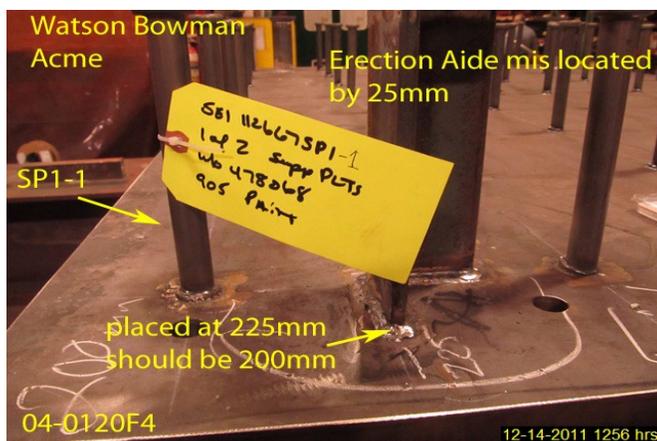
This QAI arrived at WBA as requested to green tag components to their vendor for paint. During the random observation it was noted that two (2) support plates SP3-12 and SP1-1 erection aid legs were welded in the wrong locations. WBA contacted the engineer and informed him that they would be removing these welds and re-welding them after they had magnetic particle testing performed to ensure sound base metal. Welder John Ash used a cutting blade on a grinder to remove the legs then ground the areas flush. Niagara Testing technician then performed the MT and found no linear Indication. This was witnessed by this QAI and QC onsite. Mr. Ash then proceeded to use SMAW welding process to place the 5mm single pass fillet weld for the angle to the support plate. After a visual examination of the weld they appeared to be with in compliance at the time of welding. Also noted was the welding symbol for this location on the shop drawings. WBA is submitting a revision of the drawings to include the 5mm fillet for this erection aide.
