DEPARTMENT OF TRANSPORTATION

Contract #: 04-0120F4Cty: SF/ALA Rte: 80 PM: 13.2/13.9File #: 1x.28**WELDING INSPECTION REPORT****Resident Engineer:** Casey, William**Address:** 333 Burma Road**City:** Oakland, CA 94607**Report No:** WIR-026939**Date Inspected:** 20-Dec-2011**Project Name:** SAS Superstructure**OSM Arrival Time:** 630**Prime Contractor:** American Bridge/Fluor Enterprises, a JV**OSM Departure Time:** 1530**Contractor:** American Bridge/Fluor Enterprises, a JV**Location:** Job Site

Bridge No: 34-0006**Component:** Bike Path - Skyway**Summary of Items Observed:**

CCO: 193 - Description: Modify the existing bike path box panels at the expansion joints of the Skyway portion of the SFOBB East Span Seismic Safety Program.

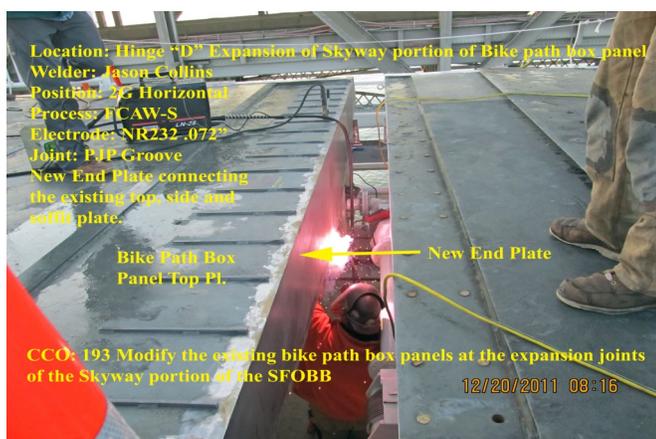
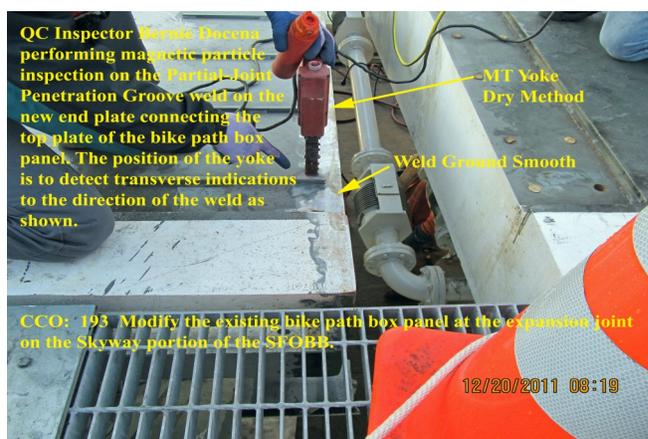
After the PJP groove weld operation was completed connecting the New End Plate to the existing top, side, diaphragm, and bottom soffit plates of the bike path box panel, this QA Inspector observed QC Inspector Mr. Bernie Docena perform a visual inspection of the PJP groove weld to verify the weld quality. The weld quality visually appeared to be in general compliance with AWS D1.5-2002 Section 3.6 and 6.26.

The 100% visual inspection and the 10% MT performed by Quality Control Inspector Mr. Bernie Docena and witnessed by this QA Inspector on the New End Plate connecting the top plate, side plate, diaphragm plate, and bottom soffit plate of the bike path box panel at expansion joint Hinge "D" appeared to be in general compliance with ASTM E709, AWS D1.5 - 2002 Section 6.26, CCO 193 and ABF Submittal number 2549 Revision 1.
