**DEPARTMENT OF TRANSPORTATION**

Quality Assurance and Source Inspection

Contract #: 04-0120F4Cty: SF/ALA Rte: 80 PM: 13.2/13.9File #: 1.28**WELDING INSPECTION REPORT****Resident Engineer:** Casey, William**Address:** 333 Burma Road**City:** Oakland, CA 94607**Report No:** WIR-026952**Date Inspected:** 20-Dec-2011**Project Name:** SAS Superstructure**OSM Arrival Time:** 700**Prime Contractor:** American Bridge/Fluor Enterprises, a JV**OSM Departure Time:** 1730**Contractor:** American Bridge/Fluor Enterprises, a JV**Location:** Job Site**CWI Name:** See below**CWI Present:** Yes No**Inspected CWI report:** Yes No N/A**Rod Oven in Use:** Yes No N/A**Electrode to specification:** Yes No N/A**Weld Procedures Followed:** Yes No N/A**Qualified Welders:** Yes No N/A**Verified Joint Fit-up:** Yes No N/A**Approved Drawings:** Yes No N/A**Approved WPS:** Yes No N/A**Delayed / Cancelled:** Yes No N/A**Bridge No:** 34-0006**Component:** SAS**Summary of Items Observed:**

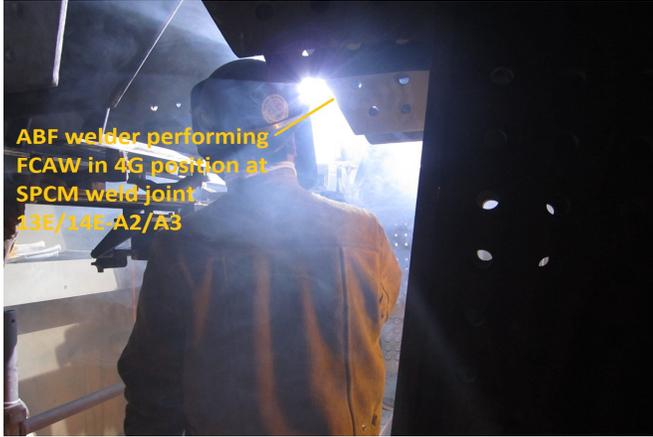
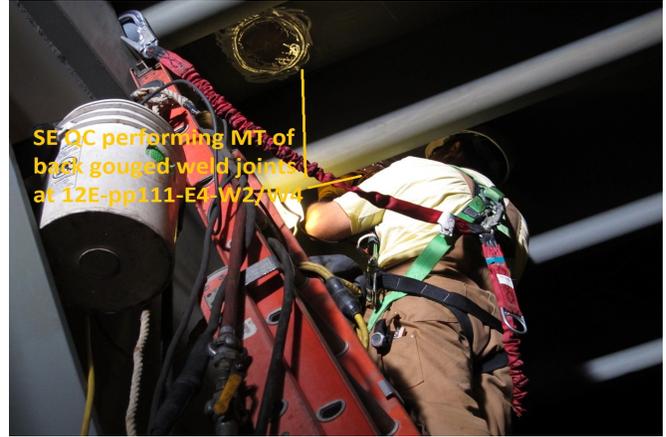
The Caltrans Quality Assurance (QA) Inspector Rick Bettencourt randomly observed the American Bridge/Fluor (ABF) welder George Lopez performing carbon arc gouging and back grinding of the above identified weld joints. It was noted prior to the arrival of the QA Inspector the top side of the weld joints had been completed and ground flush with the top deck plate. The QA inspector randomly observed the ABF welder grind the back gouged weld joints to bright metal. The QA Inspector randomly observed the back gouged weld joints and noted they appeared to be in general compliance with the contract requirements. The QA Inspector randomly observed the SE QC Inspector Salvador Moreno perform magnetic particle testing (MT) of the back gouged weld joint and noted no relevant indications were present at the time of the testing. The QA Inspector randomly observed the ABF welder continue welding the in process lifting lug hole restoration of #2 and #4. The QA Inspector noted the weld joint was approximately 50% complete at the time of the SMAW 4G back weld. The QA Inspector randomly observed the ABF welder continue the SMAW cover pass. The QA Inspector noted the ABF welder completed #2 and moved over to #4. The QA Inspector randomly observed the SMAW parameters were 1/8" E7018 low hydrogen electrodes with 115 Amps. The QA Inspector noted the parameters appeared to be in general compliance with ABF-WPS-1110A. The QA Inspector randomly observed the ABF welder did complete the above identified lifting lug holes on this date. The QA Inspector noted the weld reinforcement was ground flush on the QA Inspectors shift.

The QA Inspector randomly observed the above identified weld joint had been previously welded from the top side of the weld joint. The QA Inspector randomly observed the ABF welder James Zhen had unbolted the

maximum amount of splice plates and removed the steel backing bar from the underside of the weld joint. It was observed the weld joint had been back gouged and MT had been performed with satisfactory results. The QA Inspector randomly observed the ABF welder James Zhen had previously started the induction heating blankets on the outside of OBG to ensure the minimum required preheat of 225°F was achieved prior to and maintained during welding. The QA Inspector randomly verified utilizing a 225°F temperature indicating marker and noted the minimum required preheat had been achieved. The QA Inspector observed the ABF welder to be utilizing the semi-automated flux cored arc welding (FCAW) for the above identified weld joint. The QA Inspector randomly observed the Smith Emery (SE) QC Inspector identified as Fred Vonhoff set the FCAW machine to the parameters of the approved WPS identified as ABF-WPS-D1.5-3110-4. The QA Inspector randomly observed the FCAW parameters were 280 Amps, 24.3 Volts and a travel speed of 185mm/min. The QA Inspector noted the ABF welder continued welding the FCAW fill/cover passes for the remainder of the shift. The QA Inspector noted the A2 segment of the above identified weld joint was completed on this date.

The QA Inspector randomly observed the ABF welder Wai Kit Lai had previously started the induction heating blankets on the outside of OBG to ensure the minimum required preheat of 150°F was achieved prior to and maintained during welding. The QA Inspector randomly verified utilizing a 150°F temperature indicating marker and noted the minimum required preheat had been achieved. The QA Inspector observed the ABF welder to be utilizing the semi-automated flux cored arc welding (FCAW) for the above identified weld joint. The QA Inspector randomly observed the SE QC Inspector identified as John Pagliero set the FCAW machine to the parameters of the approved WPS identified as ABF-WPS-D1.5-3042-A-1. The QA Inspector randomly observed the FCAW parameters were 265 Amps, 24 Volts and a travel speed of 400mm/min and a calculated heat input value of .95. The QA Inspector noted the ABF welder continued welding the FCAW fill/cover passes for the remainder of the shift. The QA Inspector noted both weld segments of the above identified weld joint was completed from the inside of the OBG on this date.

The QA Inspector was informed by the SE QC Inspector Salvador Moreno, the above identified lifting lug hole weld joints were ready for QA VT verification. The QA Inspector randomly observed the QC Inspector perform MT from the bottom side of both weld joints. The QA Inspector noted no relevant indications were located at the time of the testing. The QA Inspector performed a random visual inspection of the completed weld joints and noted they appeared to in general compliance with the contract requirements.
