**DEPARTMENT OF TRANSPORTATION**

Contract #: 04-0120F4Cty: SF/ALA Rte: 80 PM: 13.2/13.9File #: 1.28**WELDING INSPECTION REPORT****Resident Engineer:** Casey, William**Address:** 333 Burma Road**City:** Oakland, CA 94607**Report No:** WIR-026953**Date Inspected:** 21-Dec-2011**Project Name:** SAS Superstructure**OSM Arrival Time:** 700**Prime Contractor:** American Bridge/Fluor Enterprises, a JV**OSM Departure Time:** 1730**Contractor:** American Bridge/Fluor Enterprises, a JV**Location:** Job Site**CWI Name:** See below**CWI Present:** Yes No**Inspected CWI report:** Yes No N/A**Rod Oven in Use:** Yes No N/A**Electrode to specification:** Yes No N/A**Weld Procedures Followed:** Yes No N/A**Qualified Welders:** Yes No N/A**Verified Joint Fit-up:** Yes No N/A**Approved Drawings:** Yes No N/A**Approved WPS:** Yes No N/A**Delayed / Cancelled:** Yes No N/A**Bridge No:** 34-0006**Component:** SAS**Summary of Items Observed:**

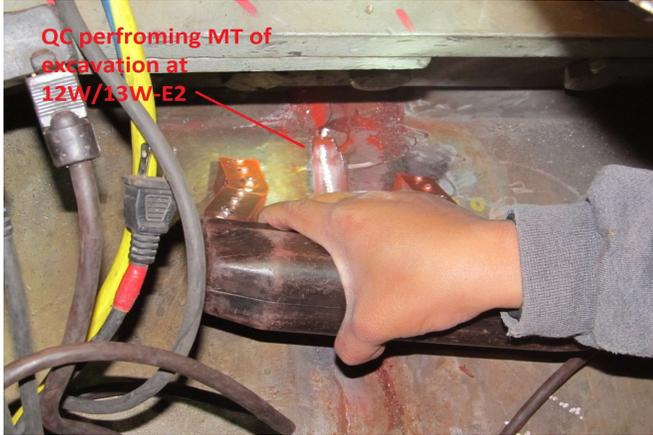
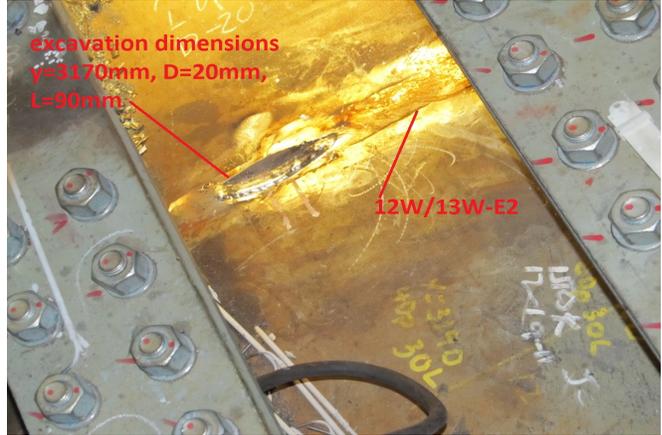
The QA Inspector randomly observed a large area of the above identified weld segment had been indicated for excavation and repair. The QA Inspector noted the repair was to be performed from the exterior side of the weld joint. The QC Inspector John Pagliero informed the QA Inspector that multiple weld defects were located at close proximity throughout the rejected area. The QA Inspector noted the ABF welder Jeremy Dolman was on site to excavate and repair the rejected area. After the rejected area was indicated directly on the ground flush weld reinforcement, the QA Inspector randomly observed the ABF welder begin excavating the weld utilizing a carbon air arc. Due to the length and the depth of the reject the excavation took several hours. After the area had been excavated, ground and blended to a weldable profile, the SE QC Inspector performed MT of the excavation. The QA Inspector noted no relevant indications were located at the time of the testing. The QA Inspector performed dimensional measurements of the excavation and noted as follows: Y=485, L=940mm, D=17mm, W=25mm. The QA Inspector randomly observed the ABF welder preheat the excavated area and surrounding base metal to the minimum required 100F. The QA Inspector randomly observed the QC Inspector verify the preheat utilizing a temperature indicating laser. The QA Inspector noted the ABF welder began the SMAW repair utilizing 1/8" E7018 low hydrogen electrodes with 110 Amps. The QA Inspector noted the preheat and welding parameters did appear to be in general compliance with ABF-WPS-1001-Repair. The QA inspector noted the repair was not completed on this date. It was observed approximately 10% of the excavation was welded on today's shift.

The QA Inspector randomly observed the ABF welder Wai Kit Lai set up the semi-automated plasma arc track system at the above identified weld joint. The QA Inspector noted the steel backing bar was still in place and was to be removed by the ABF welder. The QA Inspector randomly observed the ABF welder begin performing the plasma arc and removing the steel backing bar. The QA Inspector noted the steel backing bar was removed on the QA Inspectors shift.
