**DEPARTMENT OF TRANSPORTATION**

Contract #: 04-0120F4Cty: SF/ALA Rte: 80 PM: 13.2/13.9File #: 1.28**WELDING INSPECTION REPORT****Resident Engineer:** Casey, William**Address:** 333 Burma Road**City:** Oakland, CA 94607**Report No:** WIR-026964**Date Inspected:** 28-Dec-2011**Project Name:** SAS Superstructure**OSM Arrival Time:** 700**Prime Contractor:** American Bridge/Fluor Enterprises, a JV**OSM Departure Time:** 1730**Contractor:** American Bridge/Fluor Enterprises, a JV**Location:** Jobsite

**Bridge No:** 34-0006**Component:** SAS OBG**Summary of Items Observed:**

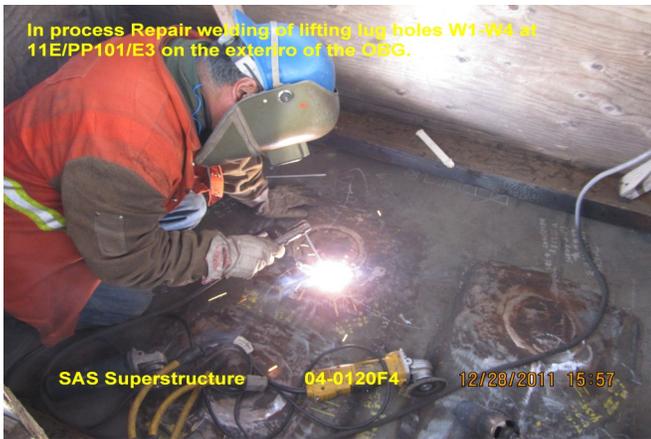
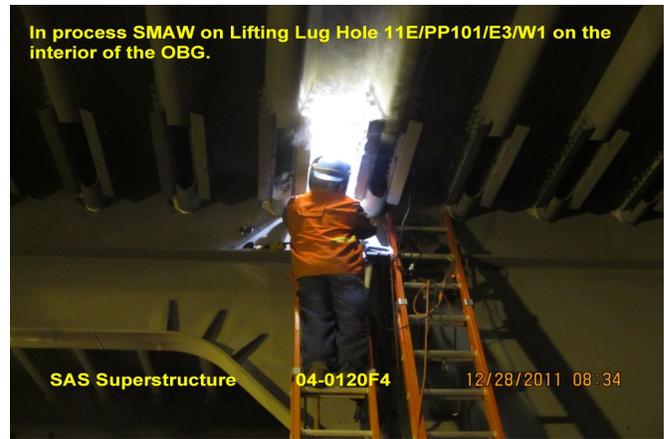
This QA Inspector randomly observed ABF welder Salvador Sandoval performing the back-gouge operation of an ultrasonic rejectable indication on "A" deck lifting lug hole W1 section 11E/PP101/E3 located at "Y" location 314 mm (25 mm wide; 60 mm length; and 7 mm in depth), "Y" 471 mm (20 mm wide; 130 mm length; and 10 mm in depth).

This QA Inspector randomly observed ABF welder Salvador Sandoval (Welder ID 2202) performing the repair welding operation on excavations as per the Shielded Metal Arc Welding (SMAW) process in the (4G) overhead position on "A" deck lifting lug hole W1 section 11E/PP101/E3. The excavated areas were as noted above and this QA Inspector observed QC Inspector John Pagliero verify that the preheat temperature was at the minimum of 150 Degrees F and that the welding parameters (Amps, Volts, and Travel Speed) were in accordance with WPS D1.5 - 1001 Repair. The welding parameters observed at this location appeared to be in general

This QA Inspector randomly observed ABF welder Salvador Sandoval (Welder ID 2202) performing the repair welding operation of ultrasonic indications as per the Shielded Metal Arc Welding (SMAW) process in the (1G) flat position on "A" deck Lifting Lug Holes W1-W4 at 11E/PP101/E3. This QA Inspector observed the use of E7018-H4R electrodes and QC Inspector Sal Merino verify that the preheat temperature was at the minimum of 10 degrees C and that the welding parameters (Amps=135) were in accordance with WPS D1.5-1001- Repair. The welding parameters observed at this location appeared to be in general compliance with approved WPS and the contract specifications.
