DEPARTMENT OF TRANSPORTATION

Quality Assurance and Source Inspection

Contract #: 04-0120F4Cty: SF/ALA Rte: 80 PM: 13.2/13.9File #: 1.28**WELDING INSPECTION REPORT****Resident Engineer:** Casey, William**Address:** 333 Burma Road**City:** Oakland, CA 94607**Report No:** WIR-026980**Date Inspected:** 30-Dec-2011**Project Name:** SAS Superstructure**OSM Arrival Time:** 700**Prime Contractor:** American Bridge/Fluor Enterprises, a JV**OSM Departure Time:** 1630**Contractor:** American Bridge/Fluor Enterprises, a JV**Location:** Jobsite

Bridge No: 34-0006**Component:** SAS OBG**Summary of Items Observed:**

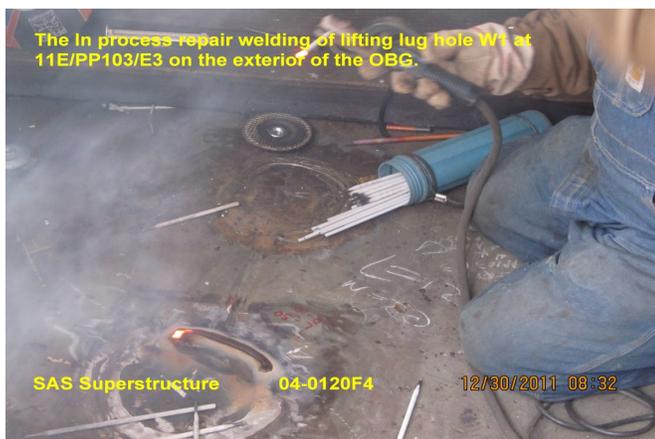
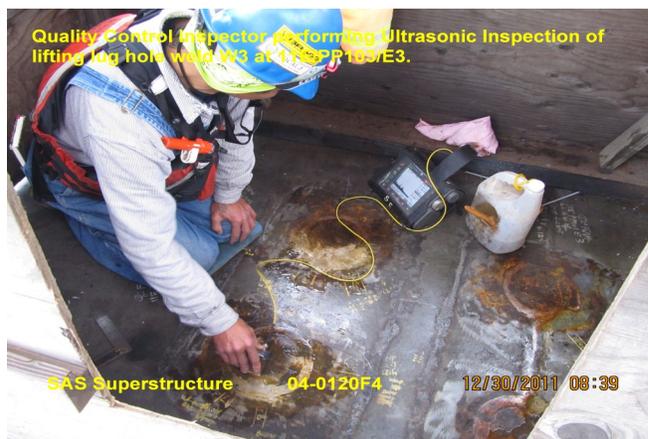
- 11E/PP103/E3/W3 Lifting Lug Hole Repair (Exterior)
 - 12W/PP111/W3 Lifting Lug Hole Welding (Exterior)
- 11E/PP103/E3/W3 Lifting Lug Hole Repair (Exterior)

This QA Inspector randomly observed ABF welder Salvador Sandoval performing the back-gouge operation of ultrasonic rejectable indications on "A" deck Lifting Lug Hole 11E/PP103/E3/W3 located at "Y" 160 mm: (20 mm wide; 120 mm length; and 10 mm in depth) "Y" 314 mm: (20 mm wide; 340 mm length; and 10 mm in depth).

This QA Inspector observed QC Inspector Sal Merino perform a Magnetic Particle Inspection (MT) of the excavation to determine the soundness of the metal. Upon completion of the testing this QA Inspector verified that no rejectable indications were present.

This QA Inspector randomly observed ABF welder Salvador Sandoval (Welder ID 2202) performing the repair welding operation of two (2) ultrasonic indications as per the Shielded Metal Arc Welding (SMAW) process in the (1G) flat position on "A" deck Lifting Lug Hole 11E/PP103/E3/W3. This QA Inspector observed the use of E7018-H4R electrodes and QC Inspector Sal Merino verify that the preheat temperature was at the minimum of 10 degrees C and that the welding parameters (Amps=135) were in accordance with WPS D1.
