**DEPARTMENT OF TRANSPORTATION**

Contract #: 04-0120F4Cty: SF/ALA Rte: 80 PM: 13.2/13.9File #: 1.28**WELDING INSPECTION REPORT****Resident Engineer:** Casey, William**Address:** 333 Burma Road**City:** Oakland, CA 94607**Report No:** WIR-026994**Date Inspected:** 04-Jan-2012**Project Name:** SAS Superstructure**OSM Arrival Time:** 700**Prime Contractor:** American Bridge/Fluor Enterprises, a JV**OSM Departure Time:** 1730**Contractor:** American Bridge/Fluor Enterprises, a JV**Location:** Job Site**CWI Name:** Salvador Merino**CWI Present:** Yes No**Inspected CWI report:** Yes No N/A**Rod Oven in Use:** Yes No N/A**Electrode to specification:** Yes No N/A**Weld Procedures Followed:** Yes No N/A**Qualified Welders:** Yes No N/A**Verified Joint Fit-up:** Yes No N/A**Approved Drawings:** Yes No N/A**Approved WPS:** Yes No N/A**Delayed / Cancelled:** Yes No N/A**Bridge No:** 34-0006**Component:** OBG Components**Summary of Items Observed:**

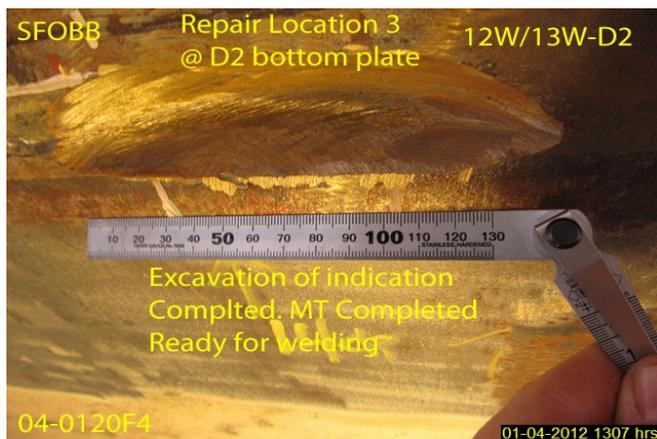
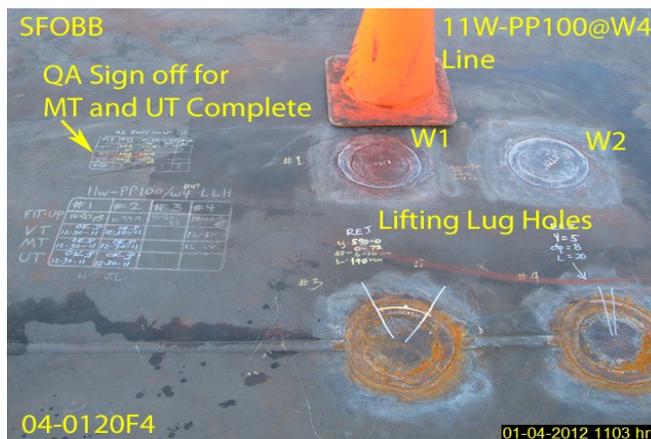
Unless noted otherwise, all work observed on this date appeared to be in general compliance with the contract documents at the time of observations.
