Contract #: 04-0120F4Cty: SF/ALA Rte: 80 PM: 13.2/13.9File #: 1.28**WELDING INSPECTION REPORT**

Report No: WIR-027007
Date Inspected: 05-Jan-2012

Project Name: SAS Superstructure
Prime Contractor: American Bridge/Fluor Enterprises, a JV
Contractor: American Bridge/Fluor Enterprises, a JV

Bridge No: 34-0006**Component:** OBG Components**Summary of Items Observed:**

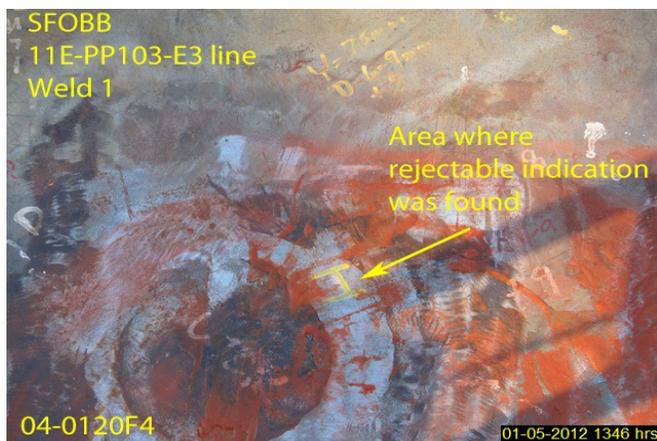
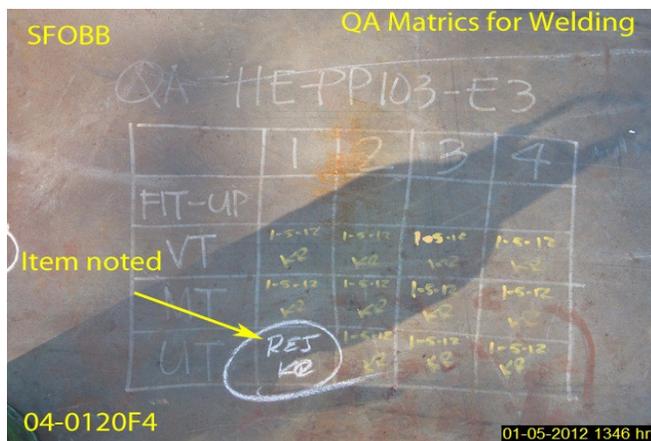
The QA inspector observed the QC activities and the welding utilizing the WPS's as noted above, which appeared to be posted at the weld station. The welding parameters and surface temperatures were verified by the QC inspectors utilizing a Fluke 337 clamp meter for the electrical welding parameters and a Fluke 63 IR Thermometer for verifying the preheat and interpass temperatures. The consumables utilized for the welding process stated appeared to comply with the AWS Specification and AWS Classification. The QC inspection, testing and welding performed on this shift appeared to be in general compliance with the contract documents. At random intervals, the QAI verified the QC inspection, testing, welding parameters and the surface temperatures utilizing various inspection equipment and gages which included a Fluke 337 Clamp Meter and Tempilstik Temperature indicators. Unless noted otherwise, all work observed on this date appeared to be in general compliance with the contract documents at the time of observations.
