DEPARTMENT OF TRANSPORTATION

Contract #: 04-0120F4Cty: SF/ALA Rte: 80 PM: 13.2/13.9File #: 1.28**WELDING INSPECTION REPORT****Resident Engineer:** Casey, William**Address:** 333 Burma Road**City:** Oakland, CA 94607**Report No:** WIR-027014**Date Inspected:** 10-Jan-2012**Project Name:** SAS Superstructure**OSM Arrival Time:** 700**Prime Contractor:** American Bridge/Fluor Enterprises, a JV**OSM Departure Time:** 1730**Contractor:** American Bridge/Fluor Enterprises, a JV**Location:** Jobsite

Bridge No: 34-0006**Component:** SAS OBG**Summary of Items Observed:**

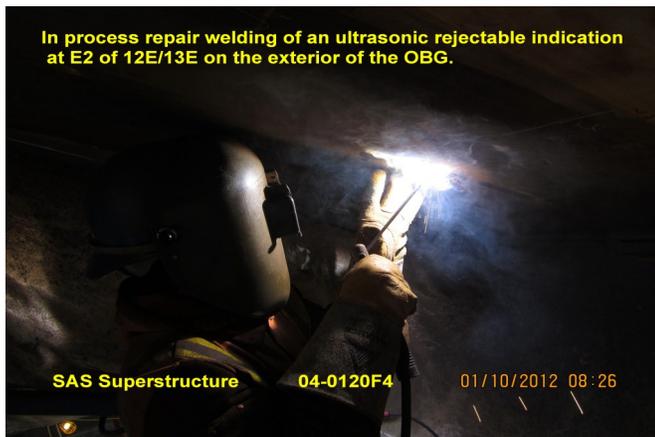
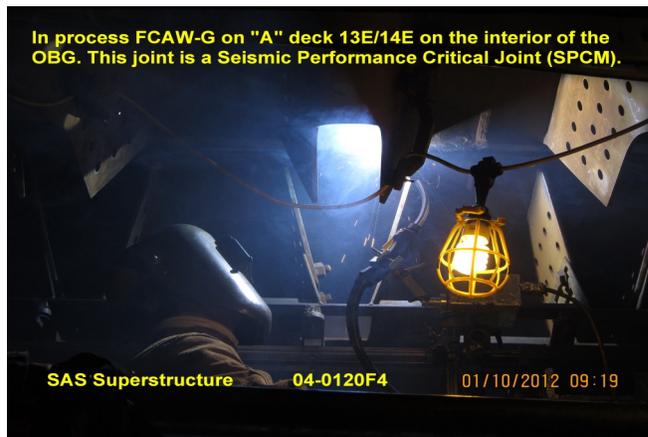
This QA Inspector randomly observed ABF welding operator James Zhen (ID 6001) performing the Flux Core Arc Welding with gas (FCAW-G) process utilizing a “Bug-O” motorized rail system with a magnetic base attached in the (4G) overhead position on face “B” of deck plate “A3”, at 12E/13E of the OBG. This QA Inspector observed QC Inspector Fred Von Hoff monitoring the welding to ensure the welding parameters were in compliance pertaining to ABF-WPS-D15-3110-4. The parameters were recorded as (A=265/V=23.7/TS=180/HI=2.09). This QA inspector made subsequent observations throughout the shift to monitor quality and noted that the work is in progress and appears to be in general conformance to the contract requirements.
