Contract #: 04-0120F4Cty: SF/ALA Rte: 80 PM: 13.2/13.9File #: 1.28**WELDING INSPECTION REPORT****Resident Engineer:** Casey, William**Address:** 333 Burma Road**City:** Oakland, CA 94607**Report No:** WIR-027024**Date Inspected:** 12-Jan-2012**Project Name:** SAS Superstructure**OSM Arrival Time:** 700**Prime Contractor:** American Bridge/Fluor Enterprises, a JV**OSM Departure Time:** 1530**Contractor:** American Bridge/Fluor Enterprises, a JV**Location:** Job Site**CWI Name:** See below**CWI Present:** Yes No**Inspected CWI report:** Yes No N/A**Rod Oven in Use:** Yes No N/A**Electrode to specification:** Yes No N/A**Weld Procedures Followed:** Yes No N/A**Qualified Welders:** Yes No N/A**Verified Joint Fit-up:** Yes No N/A**Approved Drawings:** Yes No N/A**Approved WPS:** Yes No N/A**Delayed / Cancelled:** Yes No N/A**Bridge No:** 34-0006**Component:** SAS**Summary of Items Observed:**

Skyway Portion of the SFOBB: Bike Path at Expansion Joint Hinge "B"

CCO: 193 - Description: Modify the existing bike path panels at the expansion joints of the Skyway portion of the SFOBB East Span Seismic Safety Program.

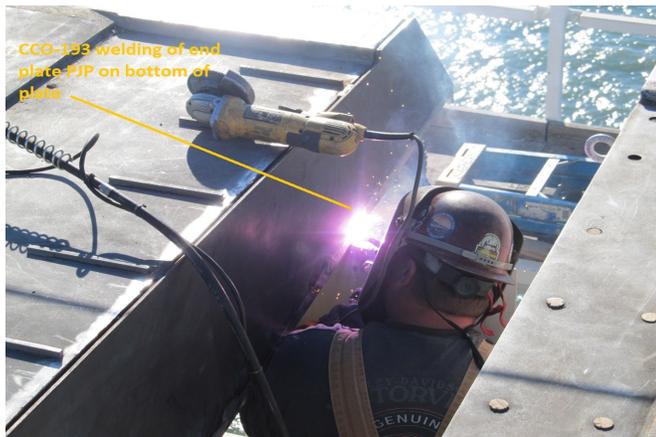
The root, fill, and cover pass weld operation observed on this date appeared to be in general compliance with the aforementioned weld procedure specification and the work observed appeared to be in general compliance with contract change order (CCO) 193.

skin plate, Side skin plate and the Diaphragm plate of the bike path box panel using an oxyacetylene cutting torch on a track system and also observed ABF personnel use a mechanical cutting blade on the existing Bottom skin soffit plate of the bike path box panel. The cut back distance was measured at 306 mm as per Contract plan sheet number 1164S8 and ABF Submittal number 2549R1. The new end plate weld operation connecting to the bike path box panel is being performed on this date as mentioned above. It was noted by the QA Inspector the welding and grinding was completed for the end plate in weld detail F1.
