Contract #: 04-0120F4Cty: SF/ALA Rte: 80 PM: 13.2/13.9File #: 1.28**WELDING INSPECTION REPORT**

Report No: WIR-027048
Date Inspected: 13-Jan-2012

Project Name: SAS Superstructure
Prime Contractor: American Bridge/Fluor Enterprises, a JV
Contractor: American Bridge/Fluor Enterprises, a JV

Skyway Bike Path Expansion Joint Modification, Contract Change Order (CCO) 193:

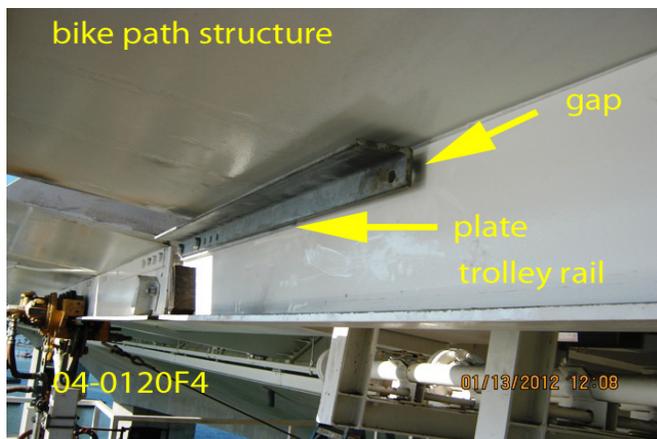
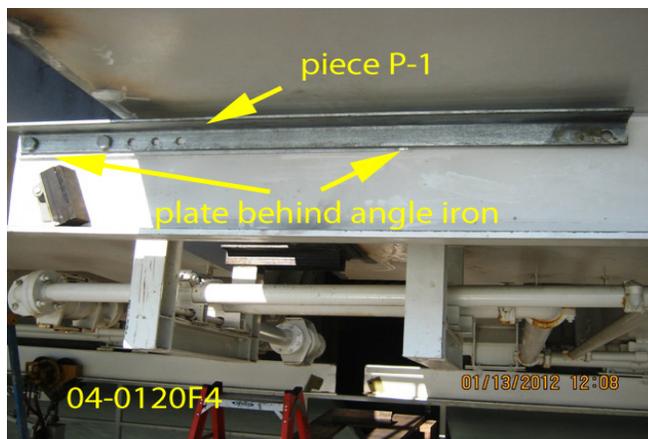
This QA Inspector reviewed the approved drawings and observed the following items: Piece P-1 is to be welded at both ends and along the leg against the trolley rail using a 5 mm fillet weld. There is an existing doubler plate at this location for approximately 75% of the length of P-1, which prevents the angle iron from contacting the trolley rail for the full length. This QA Inspector also observed the drawing calls out “prep” at the top of the angle iron corner for a Partial Joint Penetration (PJP) weld. There does not appear to be room to perform welding at this location. See photos below of the front and end view of piece P-1.
