Contract #: 04-0120F4Cty: SF/ALA Rte: 80 PM: 13.2/13.9File #: 1.28**WELDING INSPECTION REPORT**

Report No: WIR-027055
Date Inspected: 17-Jan-2012

Project Name: SAS Superstructure
Prime Contractor: American Bridge/Fluor Enterprises, a JV
Contractor: American Bridge/Fluor Enterprises, a JV

CWI Name:	See below	CWI Present:	Yes	No
Inspected CWI report:	Yes No N/A	Rod Oven in Use:	Yes No N/A	
Electrode to specification:	Yes No N/A	Weld Procedures Followed:	Yes No N/A	
Qualified Welders:	Yes No N/A	Verified Joint Fit-up:	Yes No N/A	
Approved Drawings:	Yes No N/A	Approved WPS:	Yes No N/A	
		Delayed / Cancelled:	Yes No N/A	
Bridge No:	34-0006	Component:	Emergency Gates

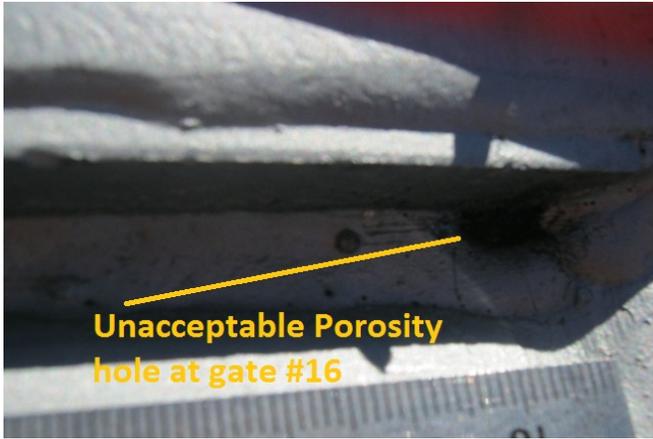
The Caltrans Quality Assurance (QA) Inspector Rick Bettencourt performed a visual inspection of the bike path emergency gates associated with CCO 179. The QA Inspector noted 28 gates arrived on site from an outside vendor. Upon arrival the American Bridge/Fluor (ABF) Quality Control (QC) personnel performed visual testing of the material. It was noted by the QA Inspector the material arrived on site without prior inspection from QC at the fabrication facility. The ABF QC personnel identified 12 of the 28 emergency gates with unacceptable groove welds and fillets welds. The QA Task Lead Bill Levell instructed the QA Inspector to perform visual testing of the gates after ABF QC had completed their inspection. The QA Inspector located several defects including unacceptable porosity and a single linear indication initiated from a piping porosity hole. The QA Inspector Rick Bettencourt and the QA Inspector Robert Mertz observed the above identified defects and concurred with them. The QA Inspector noted the SE QC Inspector Bill Norris and ABF Welding Quality Control Manager (WQCM) Jim Bowers observed the additional defects located by the QA Inspectors. The WQCM and QC Inspector concurred with the QA Inspector and agreed to reject the two additional gates along with the previous rejected 12 and increase the total of rejected emergency gates to 14. The QA Inspector noted the QC Inspector Bill Norris indicated the #14 and #16 emergency gates with red tape and added them to the stack of rejected material to be sent back to the vendor.

The QC Inspector Bill Norris and ABF WQCM Jim Bowers informed the QA Inspector that they did agree with the rejected emergency gates and they would add them to the stack of rejected material. Mr. Bowers went on to inform the QA Inspector the material will be sent back to the fabricator for repairs.
