DEPARTMENT OF TRANSPORTATION

Contract #: 04-0120F4Cty: SF/ALA Rte: 80 PM: 13.2/13.9File #: 1.28**WELDING INSPECTION REPORT****Resident Engineer:** Casey, William**Address:** 333 Burma Road**City:** Oakland, CA 94607**Report No:** WIR-027062**Date Inspected:** 18-Jan-2012**Project Name:** SAS Superstructure**OSM Arrival Time:** 700**Prime Contractor:** American Bridge/Fluor Enterprises, a JV**OSM Departure Time:** 1530**Contractor:** American Bridge/Fluor Enterprises, a JV**Location:** Job Site**CWI Name:** See below**CWI Present:** Yes No**Inspected CWI report:** Yes No N/A**Rod Oven in Use:** Yes No N/A**Electrode to specification:** Yes No N/A**Weld Procedures Followed:** Yes No N/A**Qualified Welders:** Yes No N/A**Verified Joint Fit-up:** Yes No N/A**Approved Drawings:** Yes No N/A**Approved WPS:** Yes No N/A**Delayed / Cancelled:** Yes No N/A**Bridge No:** 34-0006**Component:** Emergency Gates**Summary of Items Observed:**

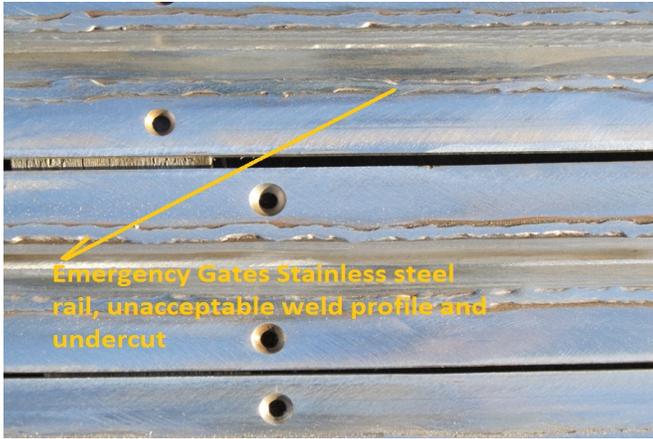
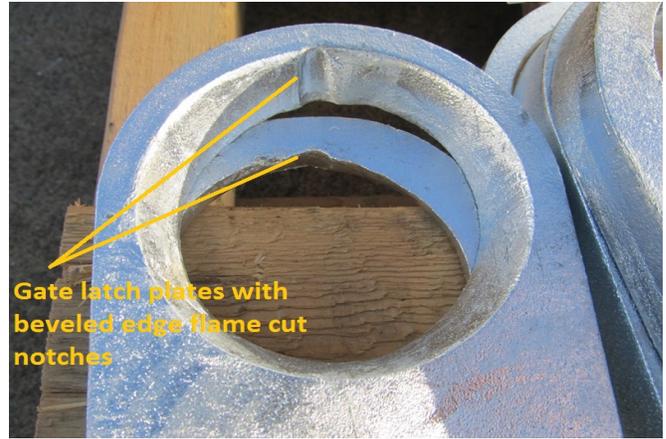
The QA Inspector performed random visual testing of the above identified components, after the inspection was completed; the QA Inspector concurred with QC Inspectors findings. The QA Inspector noted the SS rails and the gate latch plates were not in compliance with the contract requirements. The ABF WQCM Jim Bowers informed the QA Inspector the rejectable material will be sent back to the fabricator for repairs.
