DEPARTMENT OF TRANSPORTATION

Contract #: 04-0120F4Cty: SF/ALA Rte: 80 PM: 13.2/13.9File #: 1.28**WELDING INSPECTION REPORT**

Report No: WIR-027065
Date Inspected: 13-Jan-2012

Project Name: SAS Superstructure
Prime Contractor: American Bridge/Fluor Enterprises, a JV
Contractor: American Bridge/Fluor Enterprises, a JV

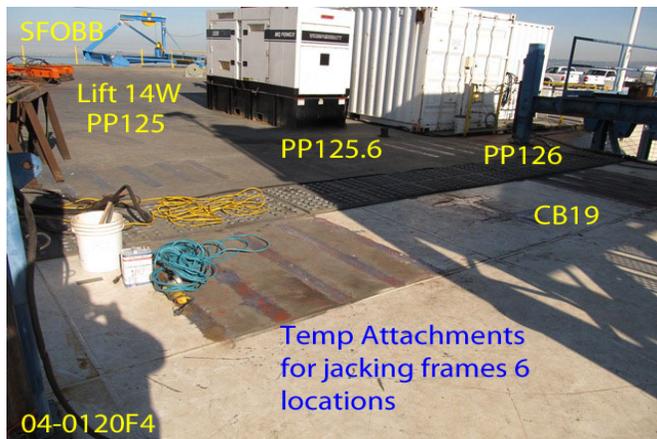
This QAI observed QC personnel Salvador Merino performing Magnetic particle on the top deck of CB19 and OBG lift 14 between Panel Points PP125~126 at the W6 line. At these locations the contractor had removed the temporary attachments of the jacking frames (See photo below) used to align the crossbeam with the OBG, FL3 area. The QC inspector Salvador Merino was observed using Magnetic Particle (MT) inspection at these locations. It was relayed that the 4 of the areas were ready for QAI review. One area needed to have weld repairs performed as noted by the QC inspector. Each area had 5 locations where the jacking frames had been removed by the contractor. This QAI performed 10% verification on the temporary attachments located at PP125 and PP126 north of W6 line. These locations at the time of the verification appeared to be within compliance of the contract documents. The location south of the W6 line at PP125 (jacking frame #3 from the west) this QAI discovered a linear indication. This information was relayed to the QC inspector who verified these findings. The linear

indication found appeared to be 30mm in length and was located approximately at the toe of the weld zone. The QC inspector stated that the contractor would have to excavate the location and perform a weld repair. This location is Seismic Performance Critical member (SPCM). The QC inspector stated this location would be documented in his report. This QAI spoke with Lead Inspector Danny Reyes who concurred with this course of action and no incident would be generated for (1) isolated location.
