Contract #: 04-0120F4Cty: SF/ALA Rte: 80 PM: 13.2/13.9File #: 1.28**WELDING INSPECTION REPORT**

Report No: WIR-027066
Date Inspected: 16-Jan-2012

Project Name: SAS Superstructure
Prime Contractor: American Bridge/Fluor Enterprises, a JV
Contractor: American Bridge/Fluor Enterprises, a JV

Bridge No: 34-0006**Component:** OBG Components**Summary of Items Observed:**

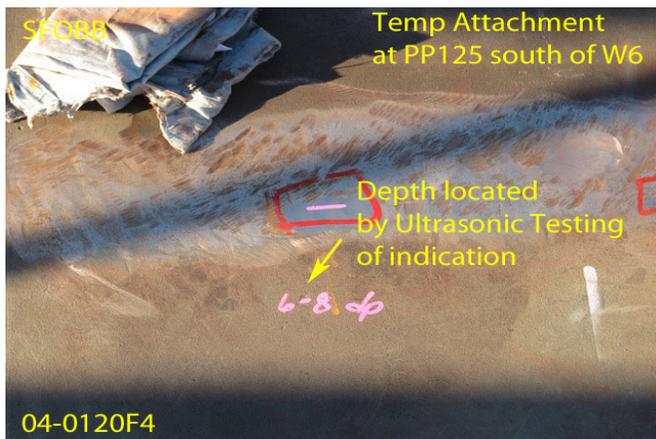
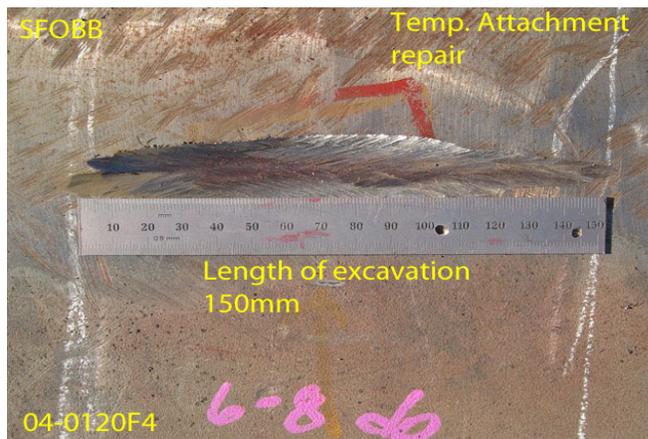
The QAI observed welder Rich Garcia, performing Shielded Metal Arc Welding (SMAW) using electrode E7018 under Welding Procedure Specification (WPS) ABF-WPS-D15-1001R for the Complete Joint Penetration weld repair. The preheat was observed as being a minimum of 60 degrees Celsius (125 Degrees Fahrenheit) with the welding current observed at 125 amps. The welder was observed using the 3.2mm electrode for this repair. The location of the welding was on the west bound lane (WB) at field splice bottom plate 12w/13w located at D3 this repair is an R2 with dimensions as follows; Length 150mm, depth-16mm and width 25mm (length 940mm). This repair location was completed and the welder proceeded to excavate 3 indications in one excavation with multiple depths. The location was at the D3 bottom plate with a Y location of 40, and depths of 14mm, 20mm, and 15mm, the accumulative length was 300mm and width of 25 mm. The QC inspector Salvador Merino was observed onsite overseeing the welding operations for this location. Mr. Merino was observed verifying and documenting the welding parameters for this location.
