DEPARTMENT OF TRANSPORTATION

Contract #: 04-0120F4Cty: SF/ALA Rte: 80 PM: 13.2/13.9File #: 1.28**WELDING INSPECTION REPORT****Resident Engineer:** Casey, William**Address:** 333 Burma Road**City:** Oakland, CA 94607**Report No:** WIR-027078**Date Inspected:** 27-Jan-2012**Project Name:** SAS Superstructure**OSM Arrival Time:** 700**Prime Contractor:** American Bridge/Fluor Enterprises, a JV**OSM Departure Time:** 1530**Contractor:** American Bridge/Fluor Enterprises, a JV**Location:** Job Site**CWI Name:** Salvador Merino**CWI Present:** Yes No**Inspected CWI report:** Yes No N/A**Rod Oven in Use:** Yes No N/A**Electrode to specification:** Yes No N/A**Weld Procedures Followed:** Yes No N/A**Qualified Welders:** Yes No N/A**Verified Joint Fit-up:** Yes No N/A**Approved Drawings:** Yes No N/A**Approved WPS:** Yes No N/A**Delayed / Cancelled:** Yes No N/A**Bridge No:** 34-0006**Component:** OBG Components**Summary of Items Observed:**

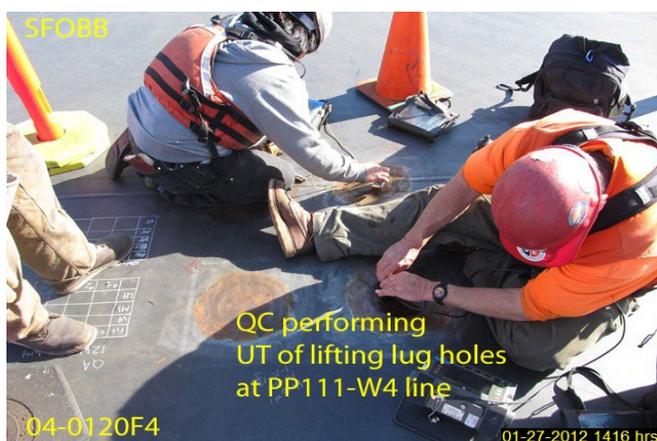
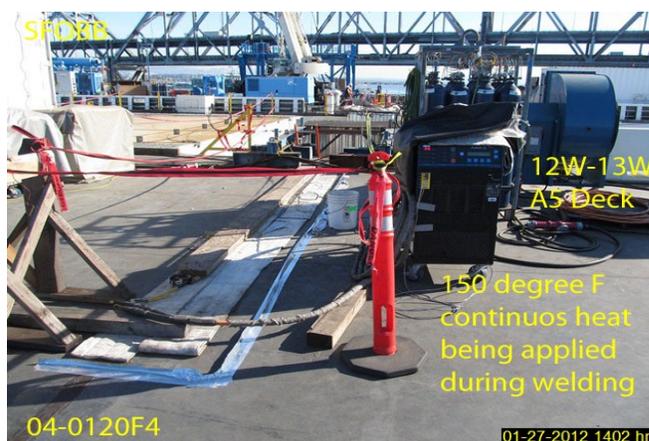
The QA inspector observed the QC activities and the welding utilizing the WPS's as noted above, which appeared to be posted at the weld station. The welding parameters and surface temperatures were verified by the QC inspectors utilizing a Fluke 337 clamp meter for the electrical welding parameters and a Fluke 63 IR Thermometer for verifying the preheat and interpass temperatures. The consumables utilized for the welding process stated appeared to comply with the AWS Specification and AWS Classification. The QC inspection, testing and welding performed on this shift appeared to be in general compliance with the contract documents. At random intervals, the QAI verified the QC inspection, testing, welding parameters and the surface temperatures utilizing various inspection equipment and gages which included a Fluke 337 Clamp Meter and Tempilstik Temperature indicators. Unless noted otherwise, all work observed on this date appeared to be in general compliance with the contract documents at the time of observations.
