Office of Structural Materials

Contract #: 04-0120F4Cty: SF/ALA Rte: 80 PM: 13.2/13.9File #: 1.28**WELDING INSPECTION REPORT****Resident Engineer:** Casey, William**Address:** 333 Burma Road**City:** Oakland, CA 94607**Report No:** WIR-027124**Date Inspected:** 01-Feb-2012**Project Name:** SAS Superstructure**OSM Arrival Time:** 700**Prime Contractor:** American Bridge/Fluor Enterprises, a JV**OSM Departure Time:** 1730**Contractor:** American Bridge/Fluor Enterprises, a JV**Location:** Job Site

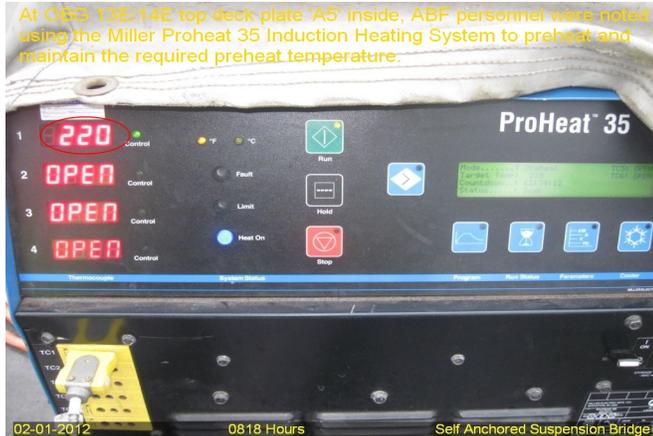
At OBS 13E/14E top deck plate 'A5' inside, ABF personnel were noted using the Miller Proheat 35 Induction Heating System to preheat and maintain the required preheat temperature.

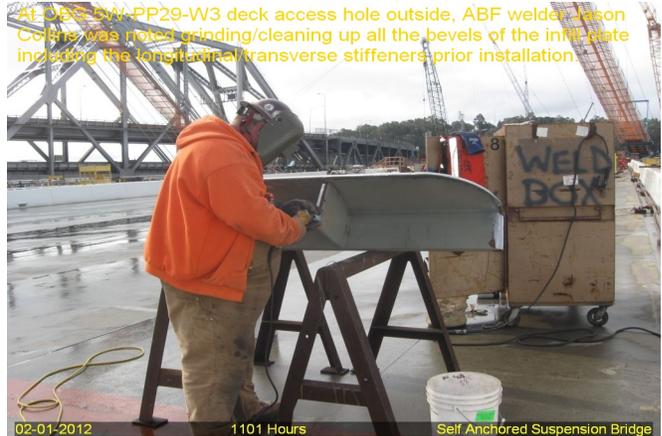
At OBS BW-PP29-W3 deck access hole outside, ABF welder Jason Collins was noted grinding/cleaning up all the bevels of the infill plate including the longitudinal/transverse stiffeners prior installation.
