Contract #: 04-0120F4Cty: SF/ALA Rte: 80 PM: 13.2/13.9File #: 99.28**WELDING INSPECTION REPORT**

Report No: WIR-027132
Date Inspected: 01-Feb-2012

Project Name: SAS Superstructure
Prime Contractor: American Bridge/Fluor Enterprises, a JV
Contractor: L & M Industrial Fabricators

South Tower Chimney Parapet:

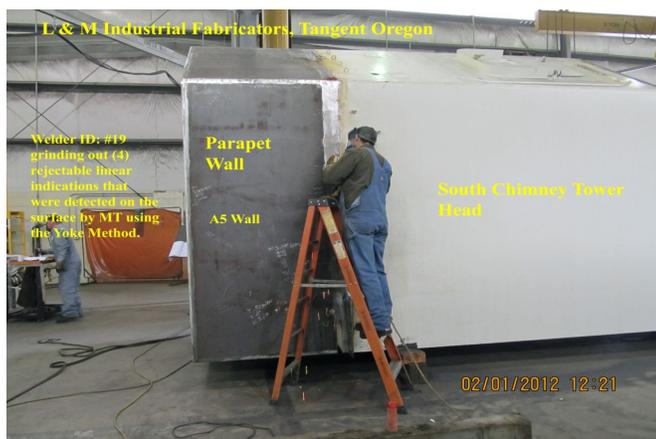
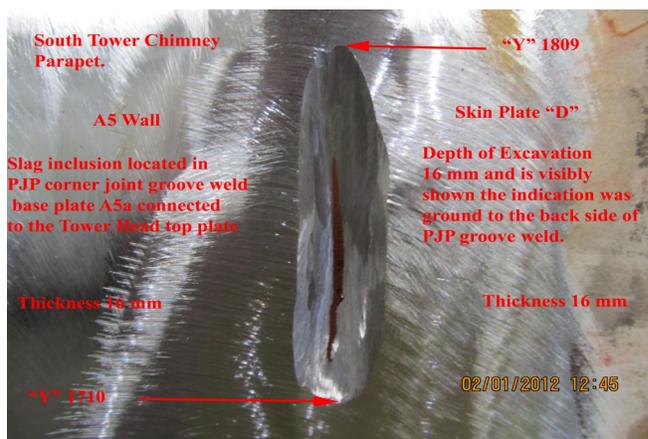
This QA Inspector observed QC NDT Inspector Troy Zuercher perform magnetic particle test (MT) inspection on previous repair areas of the partial-joint penetration (PJP) corner-joint weld connecting base plate- (A5a) to the Tower Head top plate of the South Tower Head Chimney and observed four (4) rejectable linear indications at "Y" locations (1500~1578) mm-(longitudinal to the weld); (1710~1809) mm-(longitudinal to the weld); (1835) mm-(transverse to the weld) and (1968~2028) mm-(longitudinal to the weld). This QA Inspector observed L & M welder Otis Smith (Welder ID #19) grind out the rejectable indications and prepare the U groove joint detail dimension in accordance with L & M Industrial Fabricators' WPS LM-FC-01 Repair. The depths of the four (4) rejectable linear indications were at approximately (16) mm and the widths of the U grooves varied from (16~18) mm.

position on the PJP corner-joint weld connecting base plate- (A5a) to the Tower Head top plate of the South Tower Head Chimney. The four (4) repair area dimensions and the "Y" locations were as mentioned above. This QA Inspector observed QC Inspector Tom Dreyer verify prior to the start of the repair weld operation that the minimum preheat temperature and the welding parameters (Amps and Volts) were in accordance with WPS-LM-FC-01 Repair using Hobart Excel Arc E71T-1 (.052") diameter electrode.

The repair weld operation was completed and QC NDT Inspector Troy Zuercher performed the MT inspection on the repairs areas as mentioned above and observed no rejectable indications at the time of his inspection.

This QA Inspector observed QC NDT Inspector Troy Zuercher perform magnetic particle test (MT) inspection on previous repair areas of the partial-joint penetration (PJP) corner-joint weld connecting base plate- (A4a) to the Tower Head top plate of the South Tower Head Chimney and observed two (2) rejectable linear indications at "Y" location (291~398) mm-(both indications were longitudinal to the weld). This QA Inspector observed L & M welder Otis Smith (Welder ID #19) grind out the rejectable indications and prepare the U groove joint detail dimension in accordance with L & M Industrial Fabricators' WPS LM-FC-01 Repair. The depths of the two (2) rejectable linear indications were at approximately (16) mm and the width of the U groove varied from (16~18) mm along its length.

Afterwards, This QA Inspector randomly observed L & M welder Otis Smith (Welder ID #19) performing the repair weld operation per the Flux Cored Arc Welding (FCAW-G) gas shielding process in the (3G) vertical position on the PJP corner-joint weld connecting base plate- (A4a) to the Tower Head top plate of the South Tower Head Chimney. The two (2) repair area dimensions and the "Y" location were as mentioned above. This QA Inspector observed QC Inspector Tom Dreyer verify prior to the start of the repair weld operation that the minimum preheat temperature and the welding parameters (Amps and Volts) were in accordance with WPS-LM-FC-01 Repair using Hobart Excel Arc E71T-1 (.052") diameter electrode.
