Contract #: 04-0120F4Cty: SF/ALA Rte: 80 PM: 13.2/13.9File #: 1.28**WELDING INSPECTION REPORT**

Report No: WIR-027150
Date Inspected: 06-Feb-2012

Project Name: SAS Superstructure
Prime Contractor: American Bridge/Fluor Enterprises, a JV
Contractor: American Bridge/Fluor Enterprises, a JV

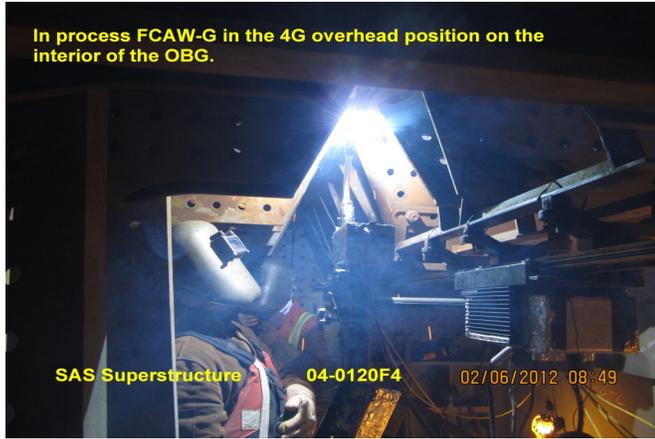
This QA Inspector randomly observed ABF welding operator James Zhen (ID 6001) performing the Flux Core Arc Welding with gas (FCAW-G) process utilizing a "Bug-O" motorized rail system with a magnetic base attached in the (4G) overhead position on the underside of deck plate "A3", at 13E/14E of the OBG. This QA Inspector observed QC Inspector Fred Von Hoff monitoring the welding to ensure the welding parameters were in compliance pertaining to ABF-WPS-D15-3110-4. The parameters were recorded as (A=240/V=23.7/TS=190/HI=1.79). This QA inspector made subsequent observations throughout the shift to monitor quality and noted that the work was completed on this date and appeared to be in general conformance to the contract requirements. This joint is a Seismic Performance Critical Member (SPCM).

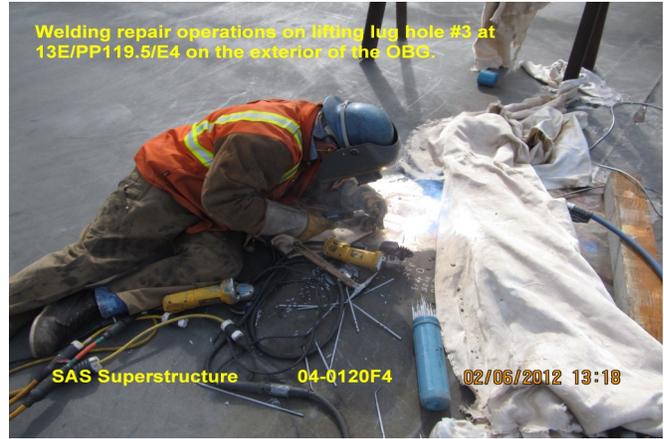
This QA Inspector randomly observed ABF welder Rick Clayborn (Welder ID 2773) performing the repair welding operation of five (5) ultrasonic indications as per the SMAW process in the (1G) flat position on "A" deck Lifting Lug Holes #1-4 at 13E PP119.5 E4. This QA Inspector observed the use of E7018-H4R electrodes and QC Inspector Fred Von Hoff verify that the preheat temperature was at the minimum of 66 degrees C and that

the welding parameters (Amps=135) were in accordance with WPS D1.5-1004- Repair. The welding parameters observed at this location appeared to be in general compliance with approved WPS and the contract specifications. Upon completion of the repair, a thermal induction blanket was placed over the area for Post Weld Heat Treatment (PWHT) at 450 degrees F for 1 hour. These joints are Seismic Performance Critical Members (SPCM).
