Contract #: 04-0120F4Cty: SF/ALA Rte: 80 PM: 13.2/13.9File #: 1.28**WELDING INSPECTION REPORT**

Report No: WIR-027153
Date Inspected: 08-Feb-2012

Project Name: SAS Superstructure
Prime Contractor: American Bridge/Fluor Enterprises, a JV
Contractor: American Bridge/Fluor Enterprises, a JV

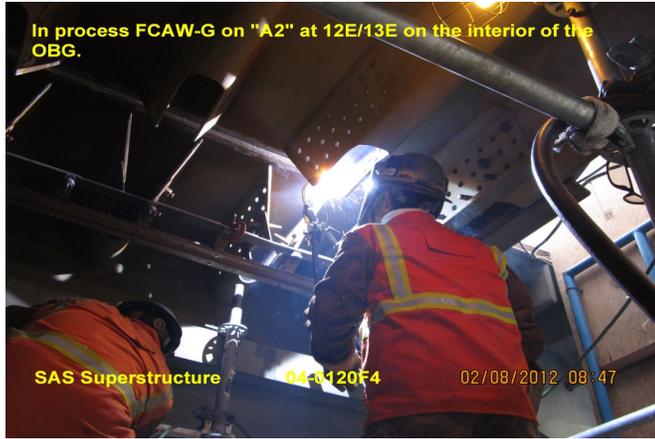
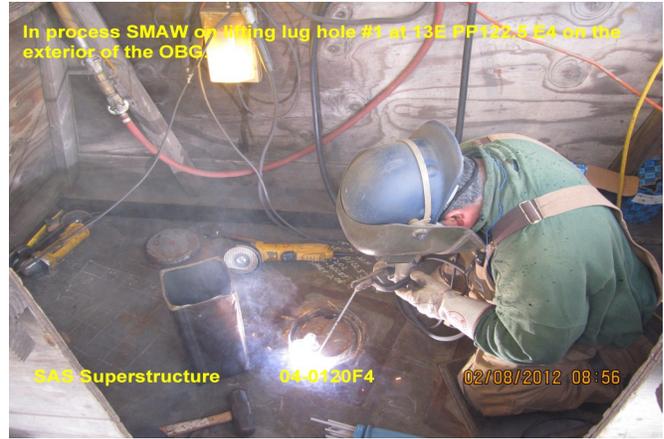
This QA Inspector randomly observed ABF welder Rick Clayborn performing the back-gouge operation of an ultrasonic rejectable indication on “A” deck Lifting Lug Hole 13E PP121.5 E3 located at y+ 256 mm: (150mm’s in length, 20mm’s wide and 17mm’s deep). This QA Inspector observed QC Inspector Fred Von Hoff perform a Magnetic Particle Inspection (MT) of the excavation to determine the soundness of the metal. Upon completion of the testing this QA Inspector noted that Mr. Von Hoff found no rejectable indications.

This QA Inspector randomly observed ABF welder Rick Clayborn (Welder ID 2773) performing the repair welding operation of an ultrasonic indication as per the Shielded Metal Arc Welding (SMAW) process in the (4G) overhead position on “A” deck Lifting Lug Hole #1 located at 13E PP121.5 E3. This QA Inspector observed the use of E7018-H4R electrodes and QC Inspector Fred Von Hoff verify that the preheat temperature was at the minimum of 66 degrees C and that the welding parameters (Amps=135) were in accordance with WPS D1.5-1004- Repair. The welding parameters observed at this location appeared to be in general compliance with approved WPS and the contract specifications. Upon completion of the repair, a thermal induction blanket was placed over the area for Post Weld Heat Treatment (PWHT) at 450 degrees F for 1 hour.
