Contract #: 04-0120F4Cty: SF/ALA Rte: 80 PM: 13.2/13.9File #: 1.28**WELDING INSPECTION REPORT**

**Report No:** WIR-027159  
**Date Inspected:** 06-Feb-2012

**Project Name:** SAS Superstructure  
**Prime Contractor:** American Bridge/Fluor Enterprises, a JV  
**Contractor:** American Bridge/Fluor Enterprises, a JV

**Bridge No:** 34-0006**Component:** OBG 13/14 W**Summary of Items Observed:**

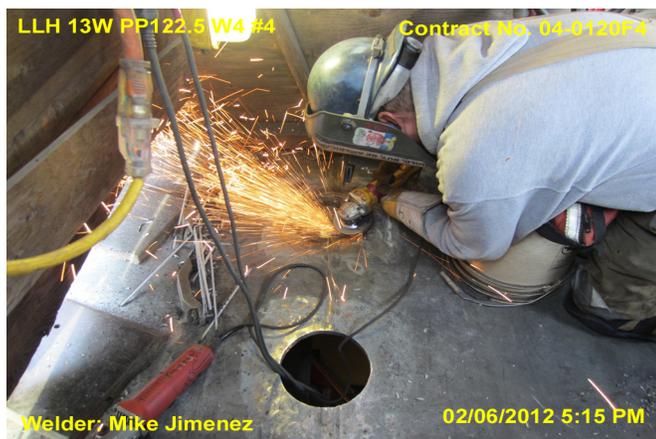
The QAI observed that welder Mike Jimenez, was welding multi-Pass fill and cover for lifting lug hole 13W PP12.5 W4 #4. This QAI observed that a copper plate was used as backing for this location as defined in Welding Procedure Specification (WPS) ABF-WPS-D15-1050A-CU. The QC inspector Steve Jenson verified the fit up for this location and found it to be acceptable, this information was relayed to the QAI. The welder then continued pre-heat throughout the area during welding using a propane type weed burner at 40 degrees Celsius (150 degrees F) which was verified using a tempstik and infrared gun by the QC. The welder was using the Shielded Metal Arc Welding (SMAW) electrode E7018 for the Complete Joint Penetration (CJP) weld in the flat (1G) position with 4.0 mm electrode for the fill pass with 185 amps and 3.2 mm electrode for the cover pass with 152 amps. The welder utilized a power grinder and power wire wheel for the interpass cleaning. The QC inspector for this location was Salvador Merino and was observed verifying and documenting the welding parameters for this location, along with overseeing the welding operations. At the time METS observation was performed. No issues were noted by the QAI.

The welder was grinding the starts and stops between weld layers to a bright metal. The location was still in process at the end of this QAI's shift.
