DEPARTMENT OF TRANSPORTATION

Contract #: 04-0120F4Cty: SF/ALA Rte: 80 PM: 13.2/13.9File #: 99.28**WELDING INSPECTION REPORT****Resident Engineer:** Casey, William**Address:** 333 Burma Road**City:** Oakland, CA 94607**Report No:** WIR-027168**Date Inspected:** 06-Feb-2012**Project Name:** SAS Superstructure**OSM Arrival Time:** 700**Prime Contractor:** American Bridge/Fluor Enterprises, a JV**OSM Departure Time:** 1530**Contractor:** L & M Industrial Fabricators**Location:** Tangent, Oregon**CWI Name:** Tom Dreyer**CWI Present:** Yes No**Inspected CWI report:** Yes No N/A**Rod Oven in Use:** Yes No N/A**Electrode to specification:** Yes No N/A**Weld Procedures Followed:** Yes No N/A**Qualified Welders:** Yes No N/A**Verified Joint Fit-up:** Yes No N/A**Approved Drawings:** Yes No N/A**Approved WPS:** Yes No N/A**Delayed / Cancelled:** Yes No N/A**Bridge No:** 34-0006**Component:** Tower Head Chimney**Summary of Items Observed:**

CCO: 196 - Description: Construct parapet walls at the Tower Heads

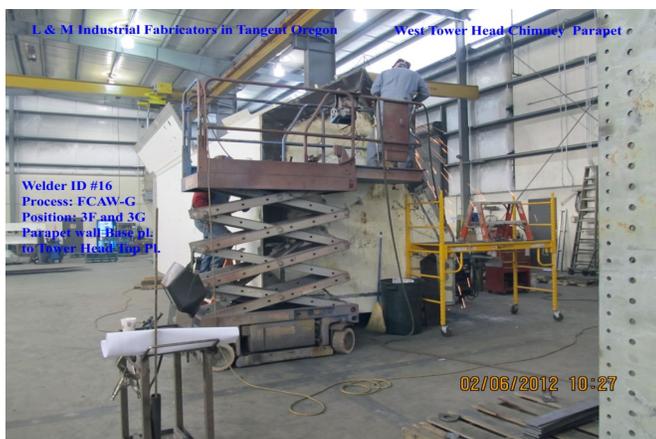
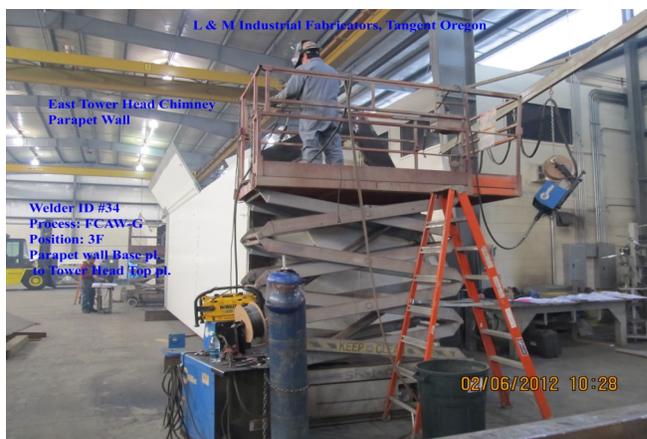
A5e, A5f, A5g, and A5h-stiffeners are welded to A5a base plate and to the A5b wall plate, and also to the A5d top plate-(internal)- (1) MT Longitudinal Centerline Indication detected on A5g-stiffener to A5a-base plate for the full width of stiffener plate -(140) mm.

A6a base plate PJP corner-joint welded to Tower Head top plate-(external)- Repair #1 - "Y" Location (820 ~ 830) mm- (Longitudinal indication that was detected on 1/27/12)- No MT Longitudinal or Transverse Indications detected and the repair area plus (50) mm on both sides of the repair were examined.
