Contract #: 04-0120F4Cty: SF/ALA Rte: 80 PM: 13.2/13.9File #: 1.28**WELDING INSPECTION REPORT**

Report No: WIR-027172
Date Inspected: 13-Feb-2012

Project Name: SAS Superstructure
Prime Contractor: American Bridge/Fluor Enterprises, a JV
Contractor: American Bridge/Fluor Enterprises, a JV

CWI Name:	As noted below	CWI Present:	Yes	No
Inspected CWI report:	Yes No N/A	Rod Oven in Use:	Yes No N/A	
Electrode to specification:	Yes No N/A	Weld Procedures Followed:	Yes No N/A	
Qualified Welders:	Yes No N/A	Verified Joint Fit-up:	Yes No N/A	
Approved Drawings:	Yes No N/A	Approved WPS:	Yes No N/A	
		Delayed / Cancelled:	Yes No N/A	
Bridge No:	34-0006	Component:	SAS OBG

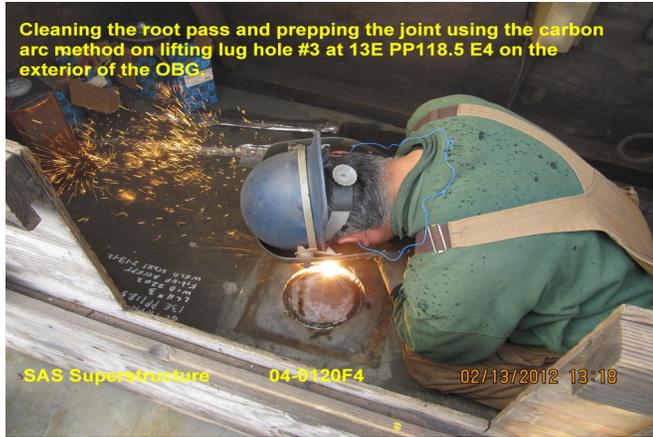
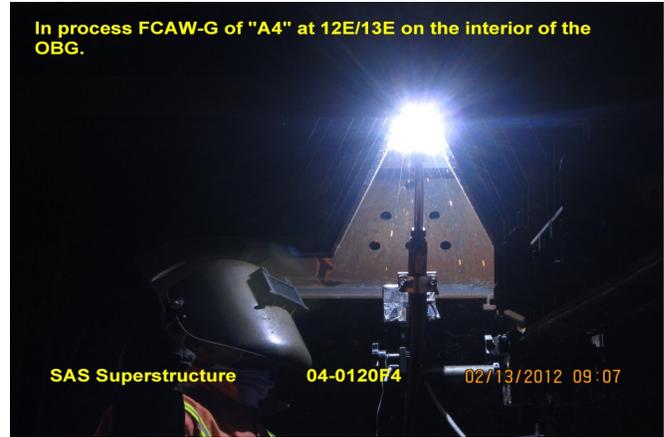
This QA Inspector observed ABF welder Salvador Sandoval (ID 2202) pre-heat the joint to 66 degrees C prior to performing Shielded Metal Arc Welding (SMAW) in the (1G) flat position on lifting lug hole #4 at 13E PP118.5 E4 on the exterior of the OBG. This QA Inspector observed the QC Inspector monitor the inter-pass temperatures and the welding to ensure the parameters were in compliance pertaining to ABF-WPS-D1.5-1050A-CU. The parameters were recorded as (Amperes=127) utilizing a 3.2 mm E7018-H4R electrode. The welder was observed grinding and blending the start/stop edges of the work between passes and throughout the joints depth. This QA Inspector made subsequent observations throughout the shift to monitor quality and noted that the work was completed on this date and appeared to be in general conformance with the contract specifications. This joint is a Seismic Performance Critical Member (SPCM).

This QA Inspector observed the welder grind and blend the edges of the hole utilizing a small disc grinder and installed the 20 mm plate to make up the B-U4a joint. This QA Inspector observed QC Inspector Fred Von Hoff measure the planar offset to be within 1 mm and this QA Inspector found it to be acceptable. This QA Inspector made random observations of ABF welding personnel Salvador Sandoval (ID#2202) performing the Shielded Metal Arc Welding process (SMAW) in the (1G) flat position on Lifting Lug Hole (LLH) #3 at 13E/PP118.5/E4. This QA Inspector observed the QC Inspector measure the pre-heat temperature to verify a minimum of 150°F was achieved. This QA Inspector also observed the QC Inspector monitoring the welding and verifying that the parameters were in compliance pertaining to ABF-WPS-D15-1050A-CU. The parameters were recorded as (Amperes=128) utilizing a 3.2 mm E7018-H4R electrode. During in process welding, this QA Inspector noted that the QC Inspector measured the inter-pass temperatures. This QA Inspector made subsequent observations throughout the shift to monitor quality and noted that the work on the exterior side of LLH #3 was completed on this date and appeared to be in general conformance with the contract documents. This joint is a seismic Performance Critical Member.
