DEPARTMENT OF TRANSPORTATION

Office of Structural Materials

Contract #: 04-0120F4Cty: SF/ALA Rte: 80 PM: 13.2/13.9File #: 99.28**WELDING INSPECTION REPORT****Resident Engineer:** Casey, William**Address:** 333 Burma Road**City:** Oakland, CA 94607**Report No:** WIR-027183**Date Inspected:** 13-Feb-2012**Project Name:** SAS Superstructure**OSM Arrival Time:** 700**Prime Contractor:** American Bridge/Fluor Enterprises, a JV**OSM Departure Time:** 1530**Contractor:** L&M Industrial Fabricators**Location:** Tangent, OR**CWI Name:** Thomas Dreyer**CWI Present:** Yes No**Inspected CWI report:** Yes No N/A**Rod Oven in Use:** Yes No N/A**Electrode to specification:** Yes No N/A**Weld Procedures Followed:** Yes No N/A**Qualified Welders:** Yes No N/A**Verified Joint Fit-up:** Yes No N/A**Approved Drawings:** Yes No N/A**Approved WPS:** Yes No N/A**Delayed / Cancelled:** Yes No N/A**Bridge No:** 34-0006**Component:** CCO 196 and 203**Summary of Items Observed:**

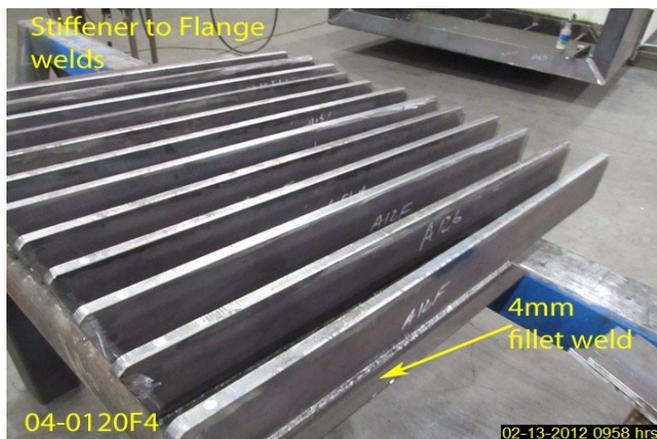
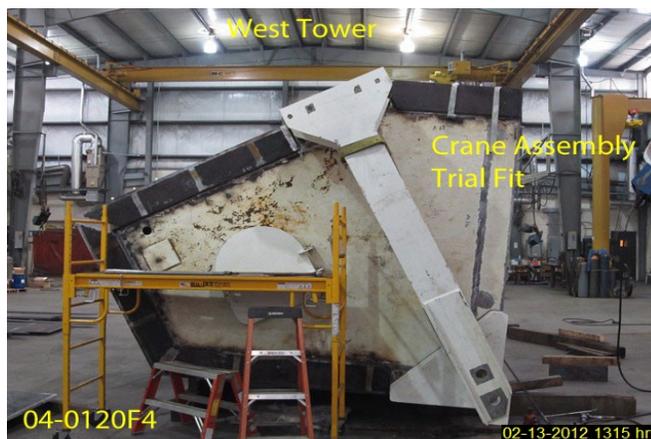
1) The bolt holes for the crane assembly to attach to the top plate are miss-aligned holes preventing the bolts to penetrate the top plate and underside brackets. This QAI observed that the miss-alignment appeared to be

approximately 5mm.

2) During the observation on the interior where the top plate and bracket meet the faying surface is not in contact and it appears that since the bracket is already bolted at 2 points (4 bolts) the faying surface would not be able to come into contact as required by contract documents. The gap was measured by this QAI inspector as being 5mm to 8mm.

During random observations by this QAI it was noted that the fabricator had used a die grinder to remove material within the bolt hole of the brackets. The amount of material removed could be up to 5mm. The fabricator had bolted the crane assembly in place so an accurate reading for these locations is unattainable at this time. The Fabricator did state that this is a dry fit for the assembly and would be removed prior to paint. This QAI will take photos of the removal area and send them to the SMR at that time. This QAI also informed the shop foreman that organic zinc would need to be applied within the bolt hole as outlined within the contract documents. Also the gap at the inside bracket that has a 8mm gap to the top plate, the fabricator was informed by the contractor to place a machined plate washer machined done for a tight fit within these areas. Caltrans has not received this document at the time the work had begun. The fabricator is working without the Engineer's approval, and is proceeding at their own risk. The shop continued throughout the shift doing the trial fit of the crane for the west tower head.
