DEPARTMENT OF TRANSPORTATION

Contract #: 04-0120F4Cty: SF/ALA Rte: 80 PM: 13.2/13.9File #: 1.28**WELDING INSPECTION REPORT****Resident Engineer:** Casey, William**Address:** 333 Burma Road**City:** Oakland, CA 94607**Report No:** WIR-027212**Date Inspected:** 15-Feb-2012**Project Name:** SAS Superstructure**OSM Arrival Time:** 700**Prime Contractor:** American Bridge/Fluor Enterprises, a JV**OSM Departure Time:** 1730**Contractor:** American Bridge/Fluor Enterprises, a JV**Location:** Job Site**CWI Name:** Steve Jensen**CWI Present:** Yes No**Inspected CWI report:** Yes No N/A**Rod Oven in Use:** Yes No N/A**Electrode to specification:** Yes No N/A**Weld Procedures Followed:** Yes No N/A**Qualified Welders:** Yes No N/A**Verified Joint Fit-up:** Yes No N/A**Approved Drawings:** Yes No N/A**Approved WPS:** Yes No N/A**Delayed / Cancelled:** Yes No N/A**Bridge No:** 34-0006**Component:** SAS OBG**Summary of Items Observed:**

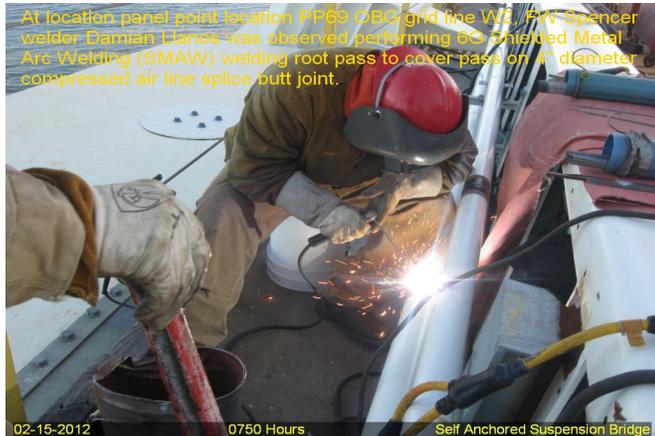
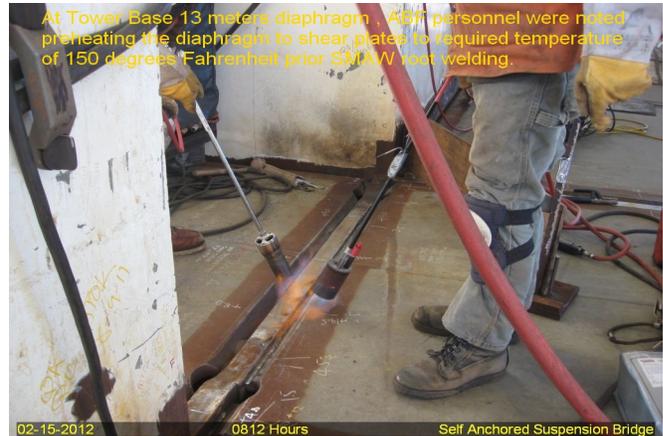
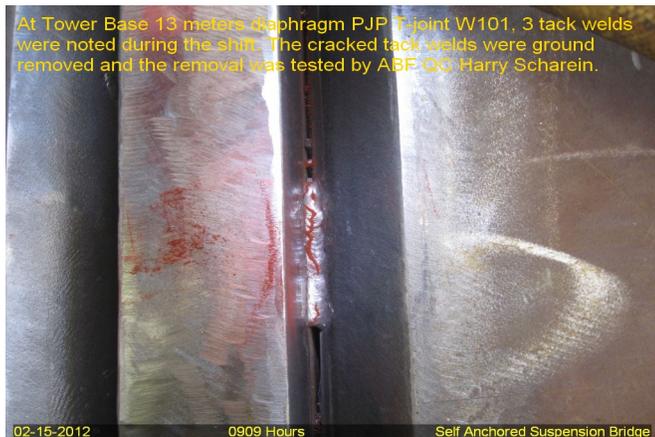
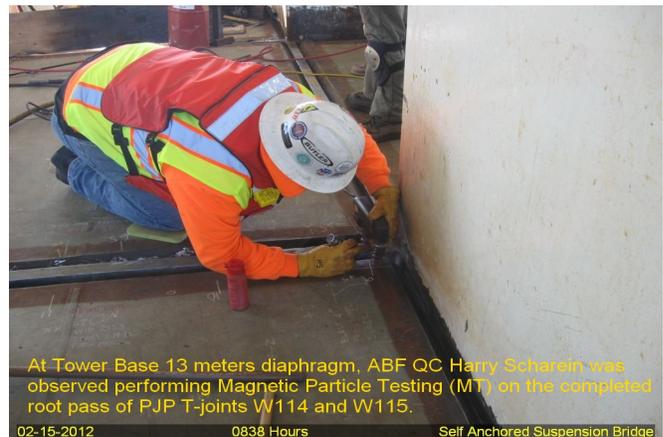
At Tower Base 13 meters diaphragm weld joint number W113, W118 and W101, ABF welder Wai Kitlai was observed perform 1G Shielded Metal Arc Welding (SMAW) welding root pass on the 45mm thick center diaphragm plate to 60mm shear plate and 45mm Tower shaft T-joints. The 45mm diaphragm has a 45 degrees bevel and has an average root opening of 4.2mm (W113), 2.7mm (W118) and 4.2mm (W101) with partial backing bar. The alignment for weld number W113 was noted 0mm minimum to +15mm maximum and for weld number W101 was noted -2mm minimum to -6mm maximum. Weld number W113 has an issue concerning the required effective throat of 36mm (per drawing detail FWT9) that will not be met considering the misalignment of +15mm (diaphragm plate is higher than the top of shear plate). This was brought to the attention of QC in which ABF QC Manager Jim Bowers went and assess the situation. Per QC Bonifacio Daquinag, the recommendation of Mr. Bowers is to weld (SAW) the top of the shear plate adjoining the two adjacent PJP T-joints due to diaphragm plate to shear plate misalignment and this will be forwarded to Caltrans for review and approval.

At Tower Base 13 meters diaphragm weld joint number W112, W117 and W103, ABF welder Jin Pei Wang was observed perform 1G Shielded Metal Arc Welding (SMAW) welding root pass on the 45mm thick North diaphragm plate to 60mm shear plate T-joint. The 45mm diaphragm has a 45 degrees bevel and has an average root opening of 4.4mm(W112), 3.0mm(W117) and 4.2 (W103) with partial backing bar. The alignment for weld number W112 was noted 0mm minimum to +8mm maximum and for weld number W101 was noted -1mm minimum to -6mm maximum. Weld number W112 has same misalignment scenario as the W113 weld joint mentioned above but same recommendation will be applied according to ABF QC.

During the shift while the two welders were welding PJP T-joints W112 and W113, three tack welds were noted cracked at W101. These noted cracks were confirmed using the MT as shown on attached photograph. ABF QC Steve Jensen instructed the welder to remove the cracked tack welds by using the disc grinder. After the complete removal of the cracked tack welds, ABF QC Harry Scharein performed MT on their removal with noted positive results.

At OBG 8W location Panel Point PP69 to PP71 grid line W2, this QA randomly observed FW Spencer qualified welder Damian Llanos perform Complete Joint Penetration (CJP) 6G (all position) Shielded Metal Arc Welding (SMAW) welding root pass to cover pass on the field splice butt joint of 2.5" and 4" domestic water and compressed air lines respectively. The system lines being welded are field weld joints of expansion joints along the grid line of W2 of the OBG. The welder was noted welding the root pass with 3/32" diameter E6010 electrode and followed by fill pass to cover pass using 3/32" diameter E7018H4R electrode implementing Caltrans approved procedure FW Spencer WPS 1-12-1. The welder was noted preheating and removing the moisture of the joint using a portable propane gas torch prior welding. During welding, ABF QC Steve Jensen was noted monitoring the parameters of the welder. At the end of the shift, the welder has completed the welding of the splice butt joints at the following;

The misalignment of +15mm (diaphragm plate is higher than the top of shear plate) was brought to the attention of ABF QC in which ABF QC Manager Jim Bowers went and assess the situation. Per QC Bonifacio Daquinag, the recommendation of Mr. Bowers is to weld (SAW) the top of the shear plate adjoining the two adjacent PJP T-joints due to diaphragm plate to shear plate misalignment and this will be forwarded to Caltrans for review and approval.
