DEPARTMENT OF TRANSPORTATION

Quality Assurance and Source Inspection

Contract #: 04-0120F4Cty: SF/ALA Rte: 80 PM: 13.2/13.9File #: 1.28**WELDING INSPECTION REPORT****Resident Engineer:** Casey, William**Address:** 333 Burma Road**City:** Oakland, CA 94607**Report No:** WIR-027219**Date Inspected:** 13-Feb-2012**Project Name:** SAS Superstructure**OSM Arrival Time:** 700**Prime Contractor:** American Bridge/Fluor Enterprises, a JV**OSM Departure Time:** 1730**Contractor:** American Bridge/Fluor Enterprises, a JV**Location:** Job Site**CWI Name:** Salvador Merino**CWI Present:** Yes No**Inspected CWI report:** Yes No N/A**Rod Oven in Use:** Yes No N/A**Electrode to specification:** Yes No N/A**Weld Procedures Followed:** Yes No N/A**Qualified Welders:** Yes No N/A**Verified Joint Fit-up:** Yes No N/A**Approved Drawings:** Yes No N/A**Approved WPS:** Yes No N/A**Delayed / Cancelled:** Yes No N/A**Bridge No:** 34-0006**Component:** OBG**Summary of Items Observed:**

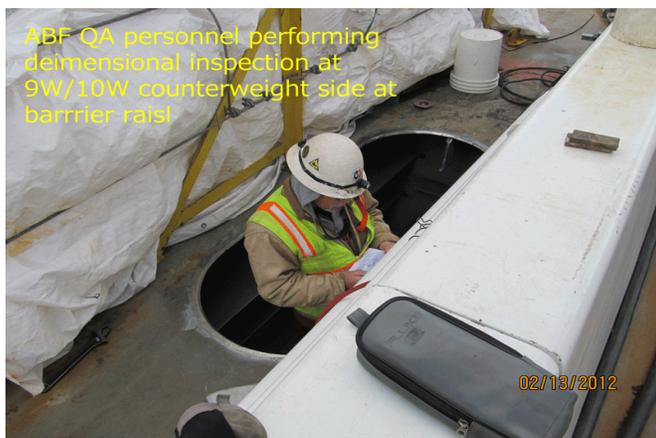
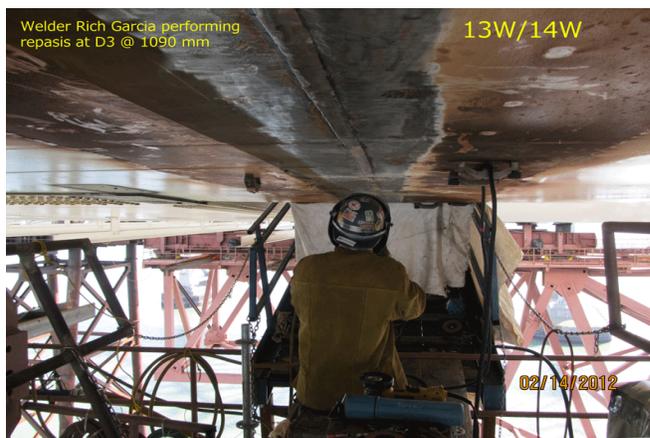
This QA inspector observed welder Rich Garcia performing air arc gouging at 13W/14W at weld #A3 on the backside of weld. Welder is removing backup strip and is back gouging and preparing root for back welding. Work is in progress at this time and further inspection verification is required.
