DEPARTMENT OF TRANSPORTATION

Contract #: 04-0120F4Cty: SF/ALA Rte: 80 PM: 13.2/13.9File #: 1.28**WELDING INSPECTION REPORT****Resident Engineer:** Casey, William**Address:** 333 Burma Road**City:** Oakland, CA 94607**Report No:** WIR-027223**Date Inspected:** 21-Feb-2012**Project Name:** SAS Superstructure**OSM Arrival Time:** 700**Prime Contractor:** American Bridge/Fluor Enterprises, a JV**OSM Departure Time:** 1730**Contractor:** American Bridge/Fluor Enterprises, a JV**Location:** Job Site**CWI Name:** Salvador Merino**CWI Present:** Yes No**Inspected CWI report:** Yes No N/A**Rod Oven in Use:** Yes No N/A**Electrode to specification:** Yes No N/A**Weld Procedures Followed:** Yes No N/A**Qualified Welders:** Yes No N/A**Verified Joint Fit-up:** Yes No N/A**Approved Drawings:** Yes No N/A**Approved WPS:** Yes No N/A**Delayed / Cancelled:** Yes No N/A**Bridge No:** 34-0006**Component:** OBG**Summary of Items Observed:**

WELDING INSPECTION REPORT

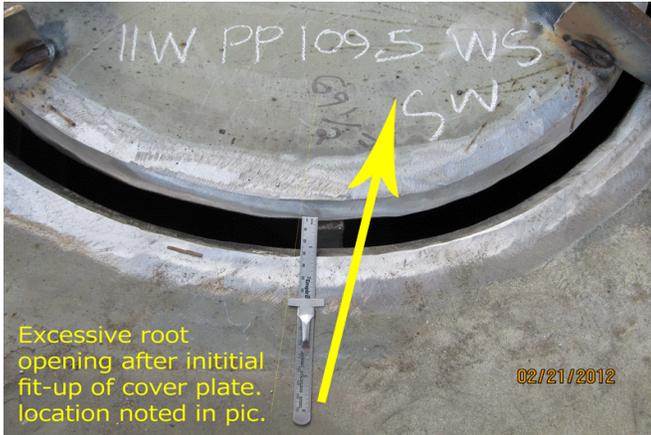
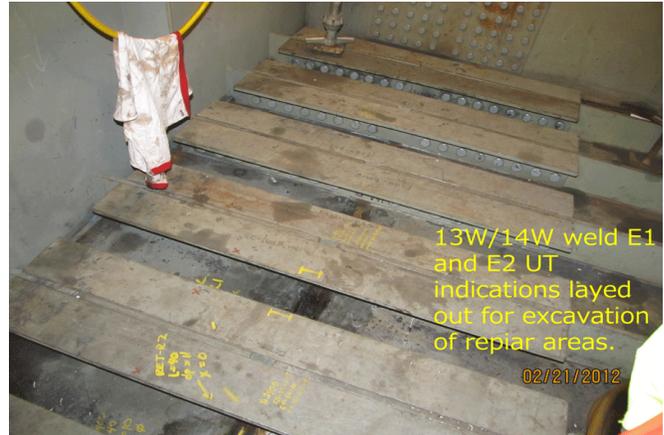
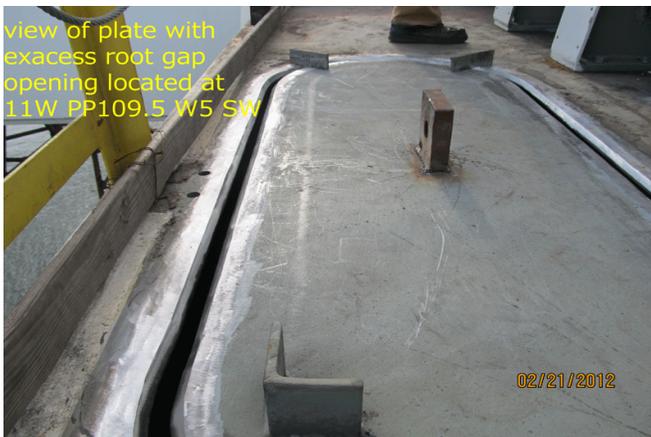
This QA inspector observed that during fitup of 20mm thick cover plate weld identified as 11W PP109.5 W5 SW had an excessive root gap around the entire circumference of the weld. QC personnel has stopped further work from occurring until a decision by ABF's engineer has been reached and a repair procedure has been recommended.
