Quality Assurance and Source Inspection

Contract #: 04-0120F4Cty: SF/ALA Rte: 80 PM: 13.2/13.9File #: 1.28**WELDING INSPECTION REPORT****Resident Engineer:** Casey, William**Address:** 333 Burma Road**City:** Oakland, CA 94607**Report No:** WIR-027301**Date Inspected:** 12-Mar-2012**Project Name:** SAS Superstructure**OSM Arrival Time:** 700**Prime Contractor:** American Bridge/Fluor Enterprises, a JV**OSM Departure Time:** 1730**Contractor:** American Bridge/Fluor Enterprises, a JV**Location:** jobsite**CWI Name:** Steve McConnell**CWI Present:** Yes No**Inspected CWI report:** Yes No N/A**Rod Oven in Use:** Yes No N/A**Electrode to specification:** Yes No N/A**Weld Procedures Followed:** Yes No N/A**Qualified Welders:** Yes No N/A**Verified Joint Fit-up:** Yes No N/A**Approved Drawings:** Yes No N/A**Approved WPS:** Yes No N/A**Delayed / Cancelled:** Yes No N/A**Bridge No:** 34-0006**Component:** SAS project**Summary of Items Observed:**

WELDING INSPECTION REPORT

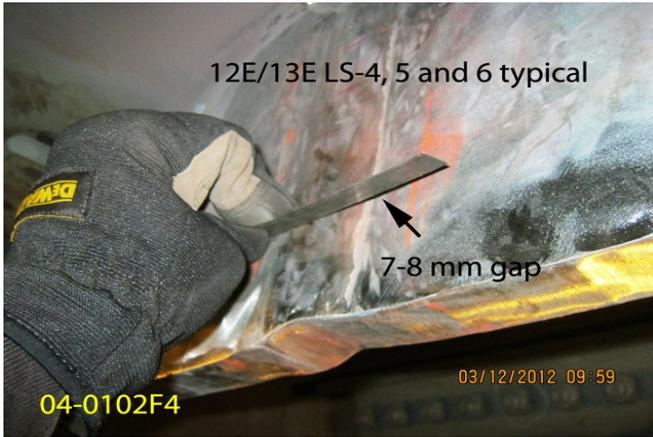
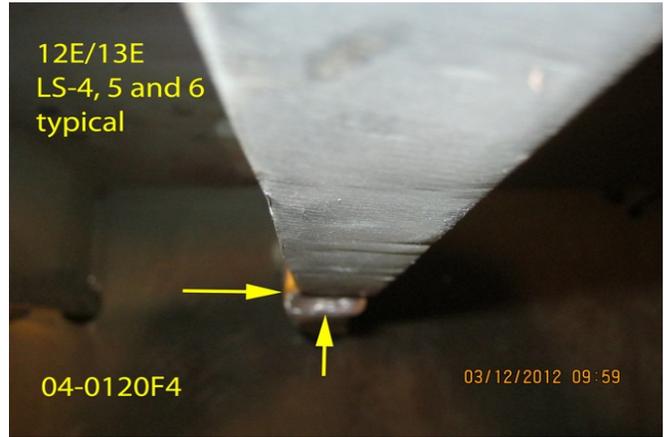
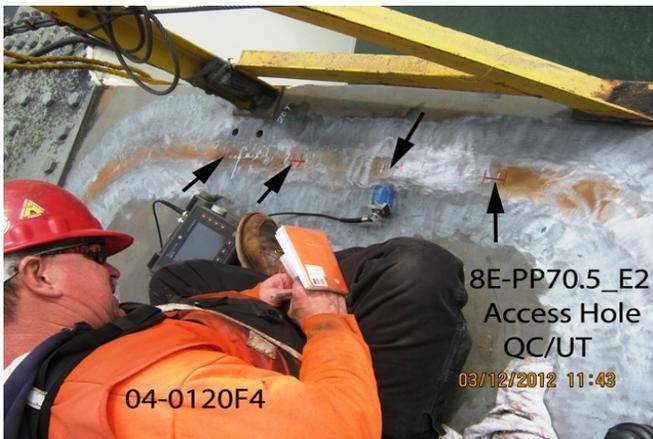
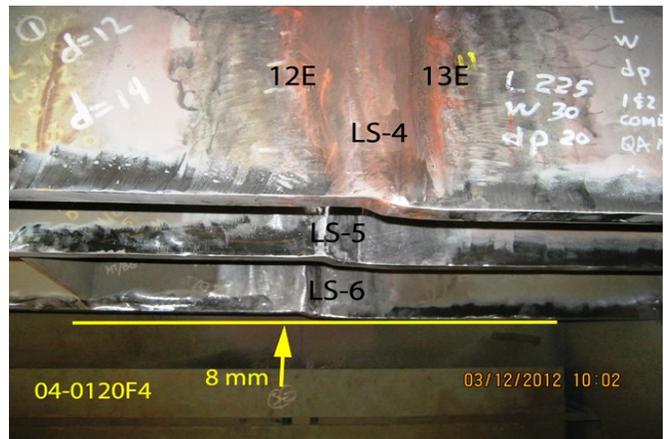
12W/13W-Longitudinal Stiffener (LS) Bottom Stiffener Flange (BSF): This QA Inspector observed the welding of the BSF's, both (North and South) on LS-4, 5 and 6 appeared to be completed. This QA Inspector observed the vast majority of the welding was in the as welded condition and required grinding. This QA Inspector observed the ends of the flanges had not been transitioned into the longitudinal stiffeners, which is required. Due to the amount of work pending pick up welding may need to be performed prior to completion. ABF welding personnel Jeremy Dolman (#5042) was moving equipment to 12E/13E LS-4, 5 and 6 to set up for welding of the BSF's at this location. This QA Inspector did not observed welding at this location this date. This QA Inspector did observe the offset, both planar and high/low plate height at this location between LS-4, 5 and 6. This QA Inspector and QC Inspectors Steve McConnell and Bonifacio Daquinag Jr. discussed the amount of offset; approximately 7-8 mm planar and 7-8 high/ low plate height. See photos below. All 3 LS locations are typical for measurements.
