DEPARTMENT OF TRANSPORTATION

Contract #: 04-0120F4Cty: SF/ALA Rte: 80 PM: 13.2/13.9File #: 1.28**WELDING INSPECTION REPORT****Resident Engineer:** Casey, William**Address:** 333 Burma Road**City:** Oakland, CA 94607**Report No:** WIR-027302**Date Inspected:** 12-Mar-2012**Project Name:** SAS Superstructure**OSM Arrival Time:** 700**Prime Contractor:** American Bridge/Fluor Enterprises, a JV**OSM Departure Time:** 1730**Contractor:** American Bridge/Fluor Enterprises, a JV**Location:** Job Site

Bridge No: 34-0006**Component:** SAS OBG**Summary of Items Observed:**

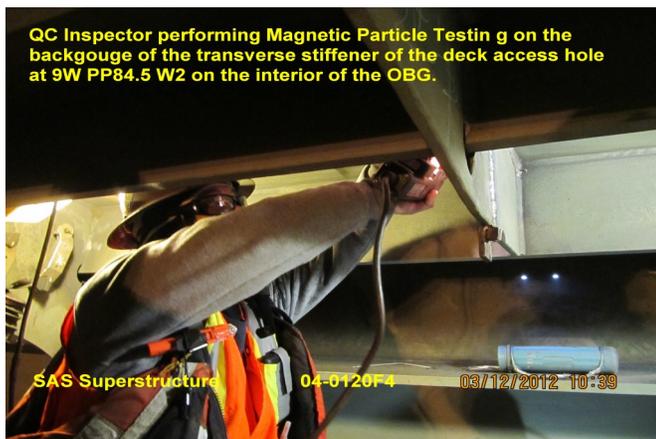
9W PP84.5 W2 TS (Interior)

This QA Inspector randomly observed ABF welder Mike Jimenez (ID 4671) performing the Shielded Metal Arc Welding (SMAW) process in the 3G vertical position on the transverse stiffener (TS) of the deck access hole (DAH) plate located at 9W PP84.5 W2 on the interior of the OBG. Prior to the start of welding, Mr. Jimenez was observed pre-heating the B-U3b complete penetration joint (CJP) to 10° C by utilizing a propane burner, this QA Inspector verified the temperature by employing a 50° F (10° C) Tempilstik. QC Inspector Steve Jensen monitored the welding and the parameters to ensure the work conformed to ABF-WPS-D1.5-1010-Revision 1. This QA Inspector observed the use of E7018-H4R electrodes secured from a remote baking oven in the vicinity and upon completion of face "A", the welder performed back-gouging operations on face "B" of the joint. QC Inspector Jesse Cayabyab tested the back-gouge by the Magnetic Particle (MT) method to ensure soundness of the metal and it was noted that Mr. Cayabyab found no rejectable indications. This QA Inspector made subsequent observations throughout the shift to monitor quality and noted that the work is in progress.

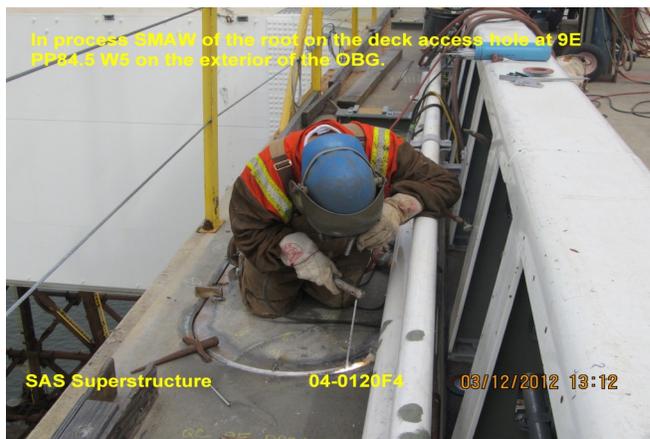
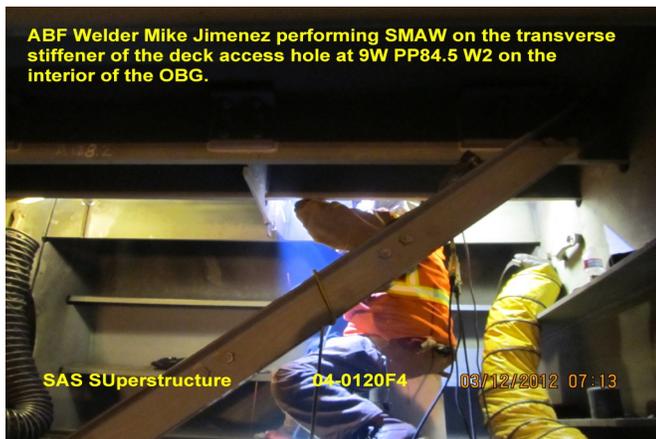
9E PP84.5 E5 Deck Access Hole (Exterior)

This QA Inspector randomly observed ABF welder Salvador Sandoval (ID 2202) perform on-going beveling

operations on "A" deck as part of the fit-up operations on the DAH at 9E PP84.5 E5 on the exterior of the OBG. Mr. Sandoval and ABF welding personnel were observed placing the plate into place by guide tabs and tack welding to complete the fit-up process. Mr. Sandoval initiated the SMAW process on the root drawing 136 amperes utilizing 3.2mm E7018-H4R electrodes. QC Inspector Steve McConnell monitored the welding and the parameters pertaining to ABF-WPS-D1.5-1010 Revision 1. This QA Inspector made subsequent observations throughout the shift to monitor quality and noted that the work was in progress.
