DEPARTMENT OF TRANSPORTATION

Office of Structural Materials

Contract #: 04-0120F4Cty: SF/ALA Rte: 80 PM: 13.2/13.9File #: 1.28**WELDING INSPECTION REPORT****Resident Engineer:** Casey, William**Address:** 333 Burma Road**City:** Oakland, CA 94607**Report No:** WIR-027314**Date Inspected:** 13-Mar-2012**Project Name:** SAS Superstructure**OSM Arrival Time:** 700**Prime Contractor:** American Bridge/Fluor Enterprises, a JV**OSM Departure Time:** 1730**Contractor:** American Bridge/Fluor Enterprises, a JV**Location:** jobsite**CWI Name:** Salvador Merino**CWI Present:** Yes No**Inspected CWI report:** Yes No N/A**Rod Oven in Use:** Yes No N/A**Electrode to specification:** Yes No N/A**Weld Procedures Followed:** Yes No N/A**Qualified Welders:** Yes No N/A**Verified Joint Fit-up:** Yes No N/A**Approved Drawings:** Yes No N/A**Approved WPS:** Yes No N/A**Delayed / Cancelled:** Yes No N/A**Bridge No:** 34-0006**Component:** SAS project**Summary of Items Observed:**

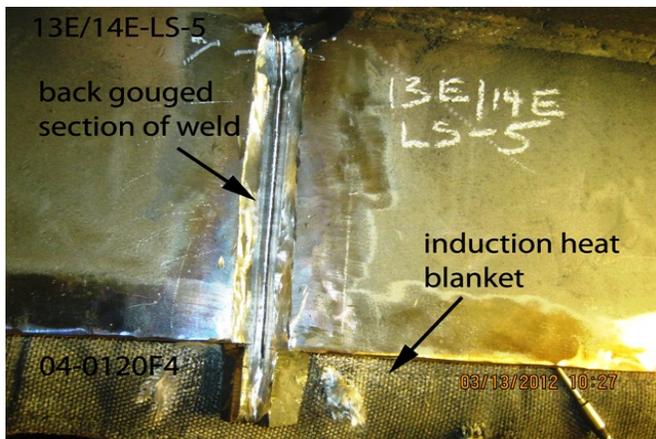
Salvador Merino perform Magnetic Particle Testing (MT) and perform a visual inspection on the back gouged weld, QC informed this QA Inspector both inspections were accepted. This QA Inspector performed a visual verification of the back gouged weld, see photo below, and observed the work appeared to comply with the contract requirements. This QA Inspector observed the induction heating blankets had been switched to the welded side and the SMAW process was continued until the weld appeared to be completed. QC Inspector Salvador Merino stated the preheating equipment had been set to provide the required 3-hour Post Weld Heat Treatment.

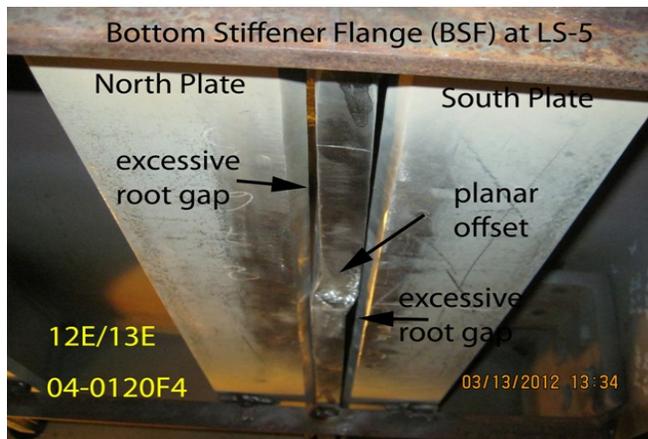
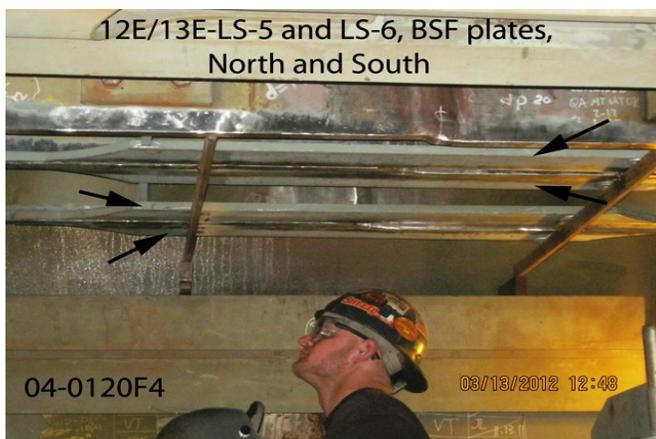
LS-5-BSF-North: root opening of 8 mm at centerline of the LS weld tapering down to 5 mm over a length of 235 mm.

LS-5-BSF-South: root opening of 10 mm at the centerline of the LS weld tapering down to 5 mm over a length of 310 mm.

The planar offset for both weld joints was -2 mm at the centerline of the LS weld reaching 0 (flush) approximately 500 mm East of LS welds and slightly greater than flush, up to +10 mm West of the centerline of the LS welds. See photos below.

This QA Inspector spoke with QC Inspectors Salvador Merino and Bonifacio Daquinag Jr. regarding the excessive root opening and areas of planar offset below flush. This QA Inspector was notified a similar issue had occurred at a different location and that QC was directed by Quality Control Manager Jim Bowers to document the specific locations of the issues for a Request For Information (RFI) to be submitted. This QA Inspector was present when QC Inspector Salvador Merino informed ABF welding personnel Rory Hogan (#3186) and Jeremy Dolman (#5042) the fit up inspection was not accepted due to the issue noted above and that an RFI was pending.
