Contract #: 04-0120F4Cty: SF/ALA Rte: 80 PM: 13.2/13.9File #: 1.28**WELDING INSPECTION REPORT****Resident Engineer:** Casey, William**Address:** 333 Burma Road**City:** Oakland, CA 94607**Report No:** WIR-027341**Date Inspected:** 16-Mar-2012**Project Name:** SAS Superstructure**OSM Arrival Time:** 700**Prime Contractor:** American Bridge/Fluor Enterprises, a JV**OSM Departure Time:** 1530**Contractor:** American Bridge/Fluor Enterprises, a JV**Location:** jobsite**CWI Name:** Salvador Merino**CWI Present:** Yes No**Inspected CWI report:** Yes No N/A**Rod Oven in Use:** Yes No N/A**Electrode to specification:** Yes No N/A**Weld Procedures Followed:** Yes No N/A**Qualified Welders:** Yes No N/A**Verified Joint Fit-up:** Yes No N/A**Approved Drawings:** Yes No N/A**Approved WPS:** Yes No N/A**Delayed / Cancelled:** Yes No N/A**Bridge No:** 34-0006**Component:** SAS project**Summary of Items Observed:**

WELDING INSPECTION REPORT

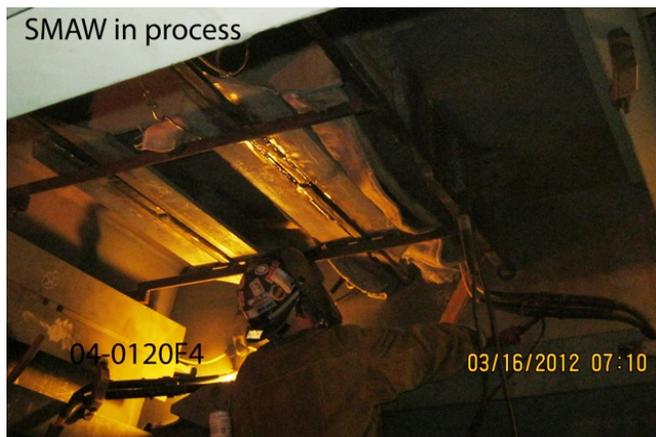
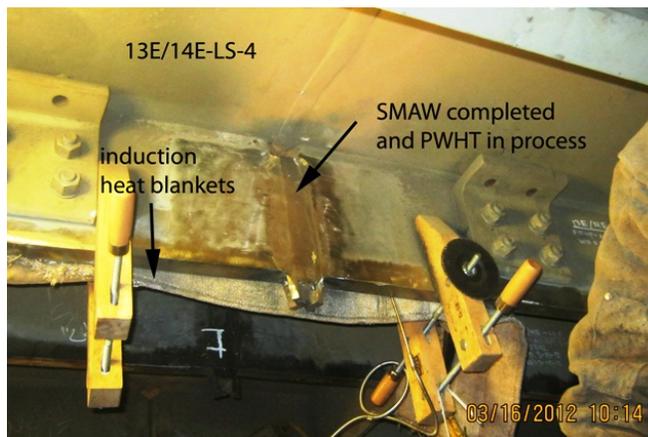
12E/13E-Longitudinal Stiffener (LS) Bottom Stiffener Flange (BSF): This QA Inspector randomly observed ABF welding personnel Jeremy Dolman (#5042) using the Shielded Metal Arc Welding (SMAW) process to weld the North and South plates. This QA Inspector observed QC Inspector Salvador Merino verify the following welding parameters; 121 amperes. This QA Inspector observed a 3.2 mm diameter, E9018 electrode was being used and verified the preheat was greater than 200°F with a temperature indicating marker. This QA Inspector reviewed Welding Procedure Specification (WPS) ABF-WPS-D15-1162-4; used by QC and observed the welding appeared to comply with the contract requirements. This QA Inspector observed a heated electrode storage container was at this work location. This QA Inspector observed welding appeared to be approximately 75% complete by the end of the shift this date.

13E/14E-Longitudinal Stiffener (LS): This QA Inspector randomly observed ABF welding personnel Richard Garcia (#5892) using the SMAW process to weld LS-4 weld joint. This QA Inspector randomly observed QC Inspector Salvador Merino verify the following welding parameters; 117 amperes. This QA Inspector used a temperature indicating marker to verify the preheat temperature was greater than 200°F and observed a 3.2 mm

diameter, E9018 electrode was being used. This QA Inspector reviewed ABF-WPS-D15-1012-3, being used by QC and observed the welding appeared to comply with the contract requirements. This QA Inspector observed a heated electrode storage container was present at this work location. This QA Inspector observed the welding appeared to be completed at approximately 0930 hours this shift and the Post Weld Heat Treatment (PWHT) had begun at this time. This QA Inspector observed the PWHT was completed at approximately 1230 hours. The previous day this QA Inspector observed two areas were marked for repair after a preliminary Ultrasonic Testing (UT) was performed on LS-5. This QA Inspector observed ABF welding personnel Richard Garcia (#5892) had excavated the two areas for repair. This QA Inspector randomly observed as QC Inspector Salvador Merino performed Magnetic Particle Testing (MT) and a visual inspection of the excavations. QC Inspector Salvador Merino informed this QA Inspector he had accepted both inspections on both excavations. This QA Inspector performed a visual verification and observed both excavations had been made from the South side of the weld; excavation #1 was 80 mm long, 25 mm wide and 15 mm deep, excavation #2 was 100 mm long, 27 mm wide and 16 mm deep. The depths of the UT defects were both marked as being 12 mm deep. The excavation areas appeared to comply with the contract requirements.
