Contract #: 04-0120F4Cty: SF/ALA Rte: 80 PM: 13.2/13.9File #: 1.28**WELDING INSPECTION REPORT**

Report No: WIR-027342
Date Inspected: 16-Mar-2012

Project Name: SAS Superstructure
Prime Contractor: American Bridge/Fluor Enterprises, a JV
Contractor: American Bridge/Fluor Enterprises, a JV

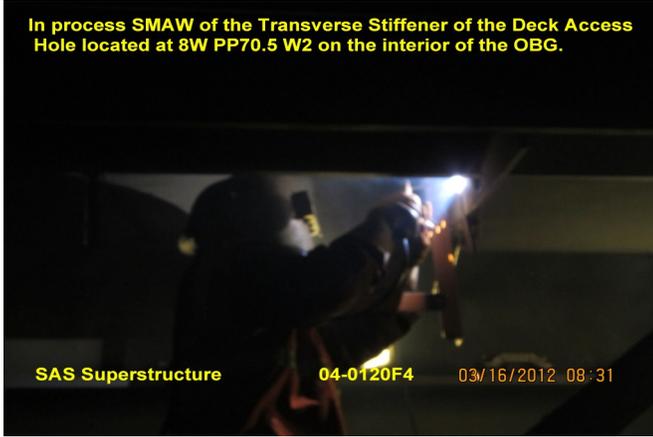
SAS Superstructure 04-0120F4 03/16/2012 08:31

This QA Inspector made random observations of the Transverse Stiffener (TS) of the DAH located at 8W PP70.5 W2 on the interior of the OBG. ABF Welder Eric Sparks was observed performing the SMAW process in the 3G vertical position utilizing 3.2mm E7018-H4R electrodes drawing amperage of 117 QC Inspector Steve Jensen was noted as being present to monitor the welding and ensure the parameters and the work conformed to ABF-WPS-D1.5-1010A-Revision1. The work was noted as being in progress as this QA Inspector made subsequent visits throughout the shift and appeared to be in general conformance with the contract documents.

In process SMAW of the Transverse Stiffener of the Deck Access Hole located at 8W PP70.5 W2 on the interior of the OBG.

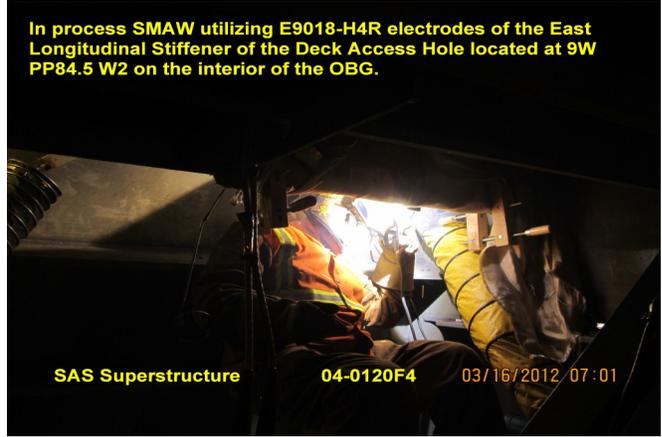
SAS Superstructure 04-0120F4 03/16/2012 07:01

This QA Inspector randomly observed ABF welder Mike Jimenez performing the SMAW process in the 3G vertical position on the East Longitudinal Stiffener (LS-E) of the DAH located at 9W PP84.5 W2 on the interior of the OBG. Mr. Jimenez was observed utilizing 3.2mm E9018-H4R electrodes with amperage of 127 and this QA

Inspector verified that they were secured from a remote baking oven in the general vicinity. It was noted that a Pro-Heat induction heating system was incorporated to provide continuous heat throughout the shift and the welder was observed grinding and blending the start/stop edges of the work with a small disc grinder and a die grinder. QC Inspector Steve Jensen was observed monitoring the welding and the parameters to ensure compliance with ABF-WPS-D1.5-1110A-Revision 0 and this QA Inspector made subsequent observations throughout the shift to monitor quality and noted that the work was in progress.

In process SMAW utilizing E9018-H4R electrodes of the East Longitudinal Stiffener of the Deck Access Hole located at 9W PP84.5 W2 on the interior of the OBG.
